Office of Highway Safety

Road Safety Audit Review

Town:	Highgate	Date Reviewed:	January 19 2016
Route:	VT 78 @ ST Armand Rd and Lamkin St	Mile points:	VT 78: 3.07

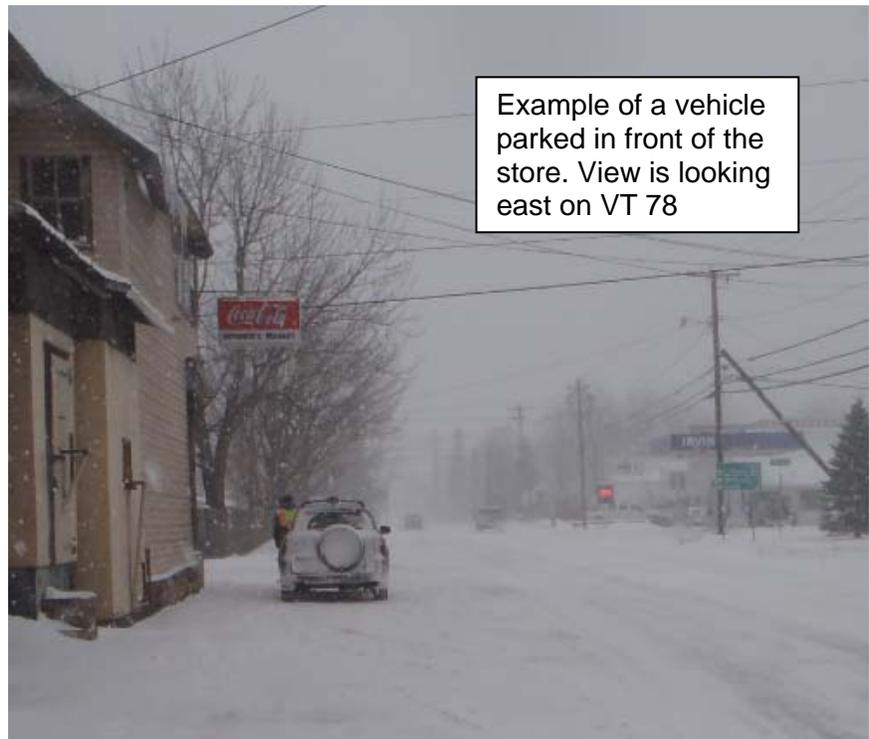
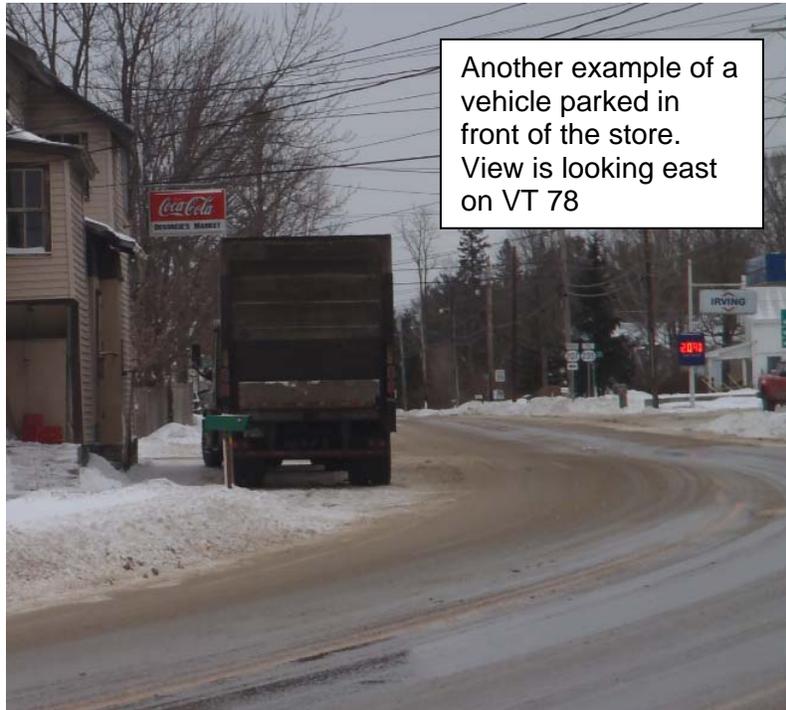
Concern: Corner Sight Distance Issue when Looking West from St Armand Road

The corner sight distance when stopped on St Armand Road and looking to the right (or west, is inadequate (measured to be 175 feet compared to desired 335 feet for a speed of 30 mph). The horizontal curve to the west of the intersection contributes to this issue.

When a vehicle is parked in front on the store, adjacent to VT 78, this issue is heightened and corner sight distance is practically zero. The delivery location in front of the store is also a factor.

Safety Enhancements:

Ensure that a clear sight triangle to the west of St Armand Road is provided.

Consideration should be given for the installation of "No Parking on the Travelled Way" sign along with crosshatched markings. A more efficient solution would be for the Town to request the Traffic Coordinating Committee that a no parking zone be instituted.

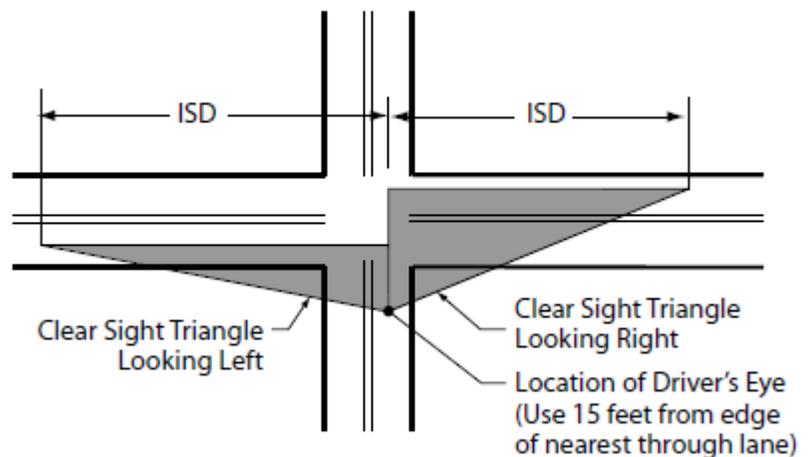
Note, Intersection Sight Distance (ISD) for 35 mph is 390 ft and 335 ft for 30 mph as per AAHSTO

Short term, construct a permanent raised island to deter motorists from parking in front of the store.

Ensure that speeds approaching from the west are low.

Immediately, revised the signage on VT 78 approaching the intersection from the west to include an intersection sign with an advisory plaque reflecting the available corner sight distance (potentially add a street name plaque and possibly combine this with a speed feedback sign). The assembly should be within 300 feet of the intersection.

Mid-term, construct a traffic calming island in the vicinity of the park and ride lot as suggested in the VT 78 pedestrian and bicycle scoping study.

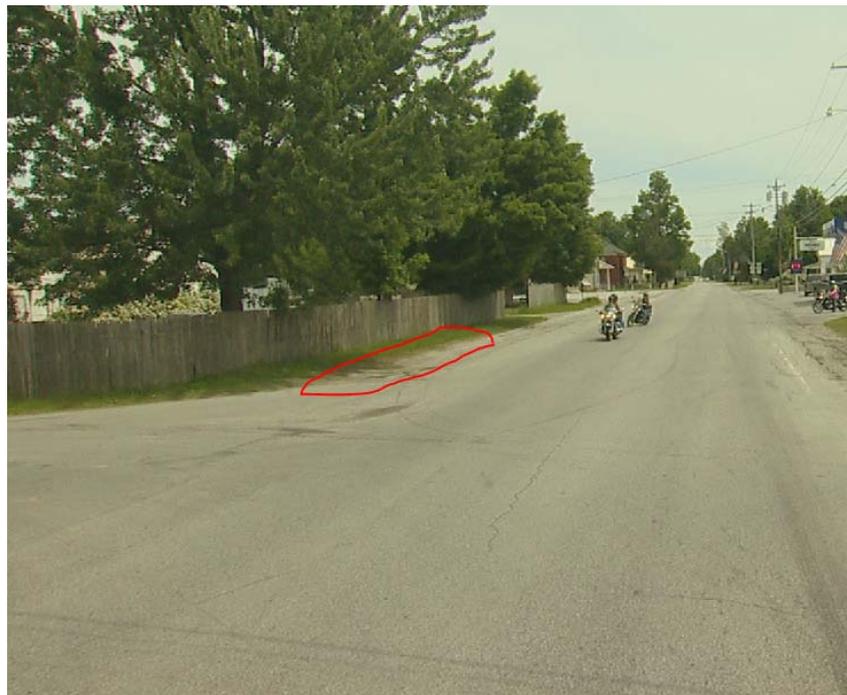
Concern: Potential Corner Sight Distance Issue when Looking East from St Armand Road

The corner sight distance from St Armand Road when looking to the left (or east) could potentially be limited if a vehicle (especially a truck) is parked on VT 78 in the shoulder along the wooden fence.

Safety Enhancements:

Consider the installation of “No Parking on the Travelled Way” sign along with crosshatched markings. A more efficient solution would be for the Town to request the Traffic Coordinating Committee that a no parking zone be instituted.

Long term, construct the sidewalk proposed by the VT 78 pedestrian and bicycle scoping study for the north side on VT 78, east of the St Armand Road intersection.
