Highgate Municipal Building: ADA Compliance Evaluation

ARNOLD & SCANGAS ARCHITECTS

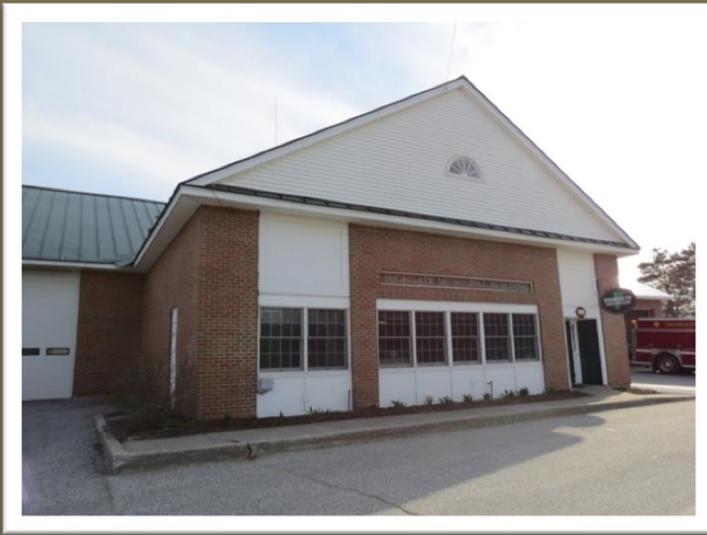
Front Entrance: Non-Accessible Entrance

- It is preferred that the front entrance be the accessible entrance. The front entrance is not accessible. The accessible entrance is located at the rear of the building. When the front is not the accessible entrance. Signage is required directing visitors from the front entrance to the accessible entrance at the rear of the building
- A directional sign, using the universal symbol for accessibility should be placed at the front of the building indicating the location of the accessible entrance

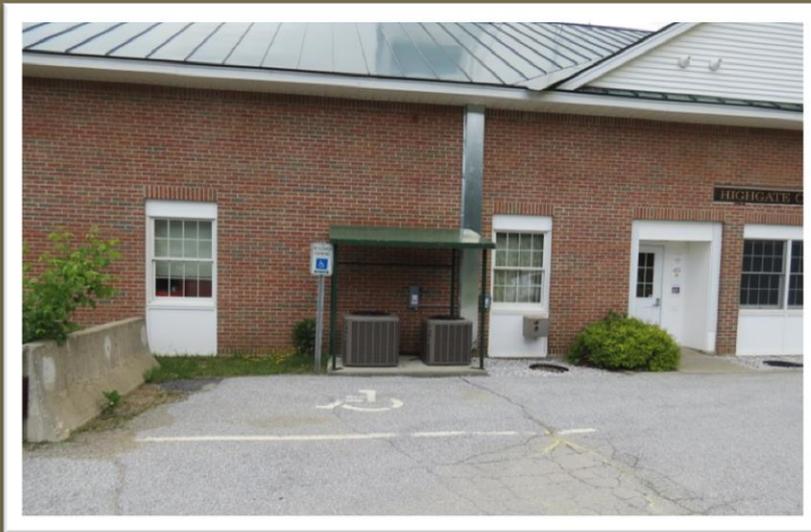
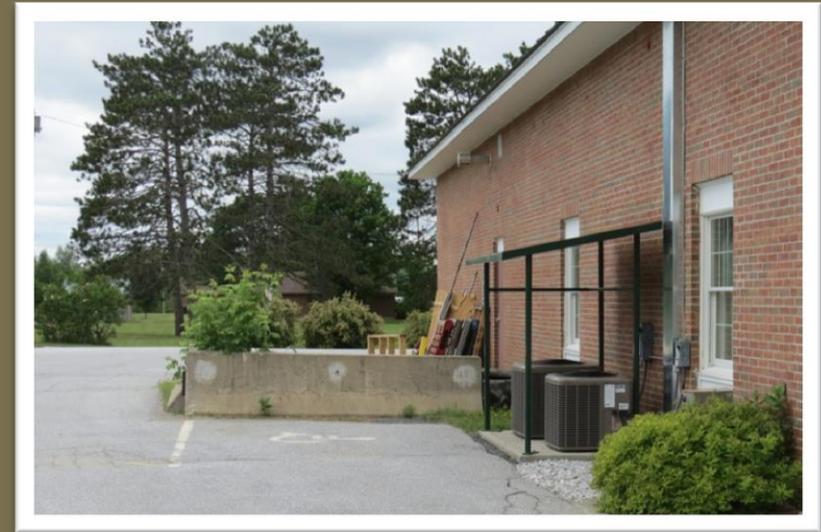
Back Entrance: Non-Accessible Parking

- The space is more than 8' wide which meets the guidelines, but does not provide a marked access aisle of at least 8'-0" wide for van accessible maneuvering
- As currently located, if the access aisle was marked, it would be in the travel lane, which is non-complaint
- The bottom of the accessible sign space designation is 56 1/4" off the ground and does not meet the minimum height of 60" off grade.

- Relocate accessible parking space to allow for a van accessible aisle that is not in the designated path of travel
- Provide a “van accessible” sign for the space where the bottom of the sign is at least 60” off grade.
- Reconfigure exterior door landing to allow for a level 5’-0” turning radius landing at doorway.
- Provide a curbed ramp with curb ramp flares
- Provide sign at front entrance stating the accessible entrance is located in the rear of the building.
- Allow accessible entrance to be used independently during regular business hours.
- Provide new sign with the international symbol of accessibility.

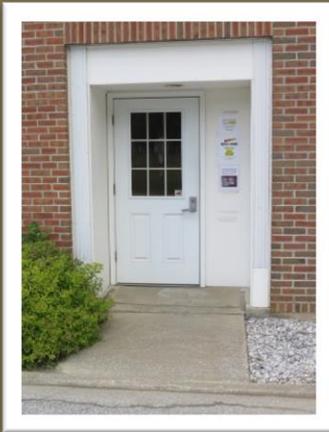
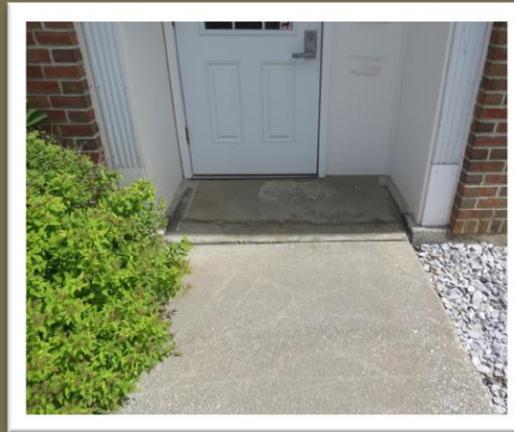
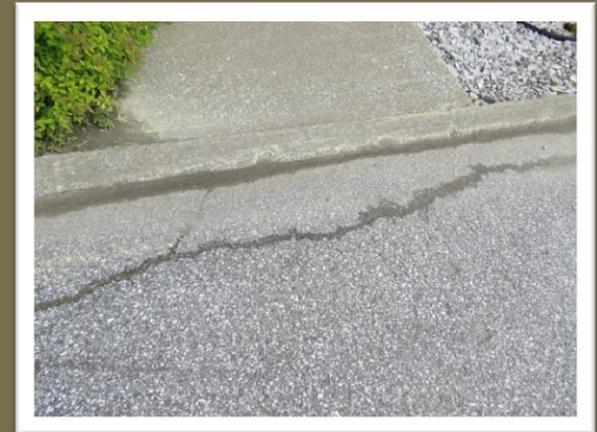
Back Entrance: Non-Accessible Entrance

- The rear entrance is locked during the day and cannot be use independently during the same business hours as the front entrance.
- The rear entrance does not contain a sign with the international symbol of accessibility, indicating that this is the accessible entrance.
- The landing in front of the exterior entrance is not level and has a number of changes in elevation, the total change in height is approximately 6" from finish floor to top of pavement.
- The existing entrance door at the exterior does not have the required 4'-0" clearance depth.
- The accessible entrance has a curb that protrudes out of the ground more than 1/4"

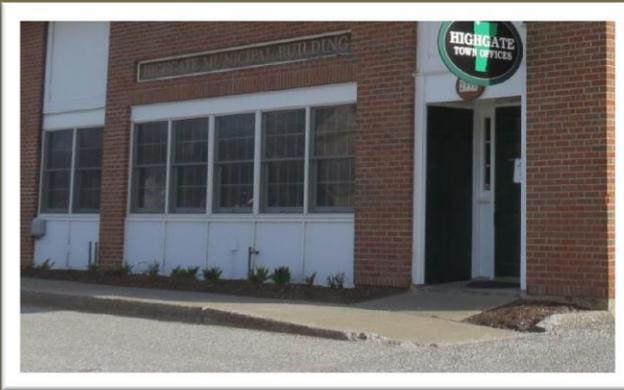
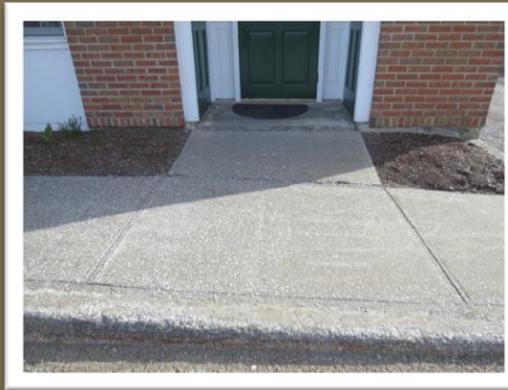
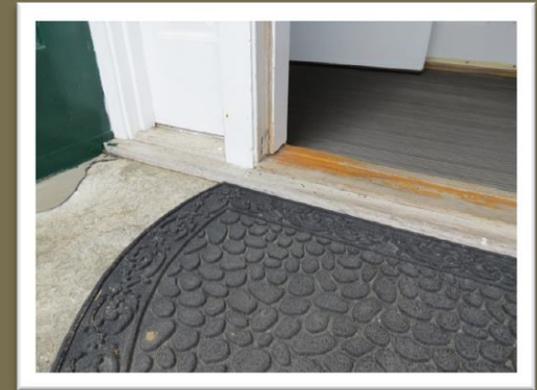
Front Entrance: Non-Accessible Entrance

- There is an existing concrete sidewalk that runs along the front of the building. Where the sloping concrete sidewalk meets the pavement there is a change of level that is more than $\frac{1}{2}$ " and is non-complaint
- The existing sidewalk that connects the sidewalk along the building to the landing at the front door, slopes and has a change of level at the front door landing that is more than $\frac{1}{2}$ " and is non-complaint
- While the existing concrete in front of the door is level. There is an approximately 1" vertical change of level at the existing door threshold. A $\frac{3}{4}$ " change is allowed for existing thresholds, however the vertical face on the threshold may not exceed a $\frac{1}{4}$ ", above that height the threshold must be beveled.
- The existing exterior entrance door does not have the required 4'-0" level clearance depth.

- Provide a new van accessible parking space including a van accessible aisle
- Provide a “van accessible” sign for the parking space where the bottom of the sign is at least 60” off the grade.
- Provide an accessible ramp with railings from the accessible parking space side and stairs with railings from the fire station side.
- Remove a portion of the exterior vestibule wall to provide the 5’-0” turning radius at the interior of the vestibule and to provide 1’-6” clearance at the pull side of the interior vestibule door.
- Provide new ADA accessible thresholds at both the exterior and interior doors

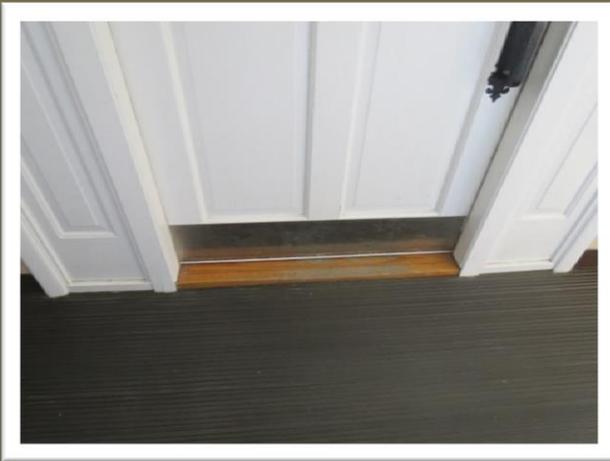
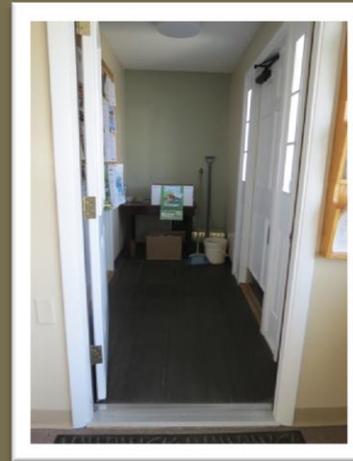
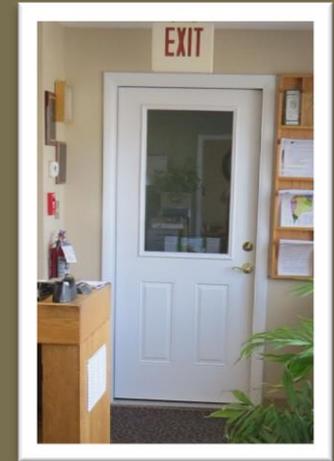
Front Entrance: Non-Accessible Entrance

- There is an approximately $\frac{3}{4}$ " vertical change of level at the existing exterior door threshold. A $\frac{3}{4}$ " change is allowed for existing thresholds, however the vertical face on the threshold may not exceed a $\frac{1}{4}$ ", above that height thresholds must be beveled.
- The existing interior vestibule does not have a 5'-0" turning radius
- At the interior of the existing vestibule door, there is not the required 1'-6" clearance from the latch side of the door to the corner
- There is an approximately $\frac{1}{2}$ " vertical change of level at the existing interior vestibule door threshold. A $\frac{3}{4}$ " change is allowed for existing thresholds, however the vertical face on the threshold may not exceed a $\frac{1}{4}$ ", above that height thresholds must be beveled.

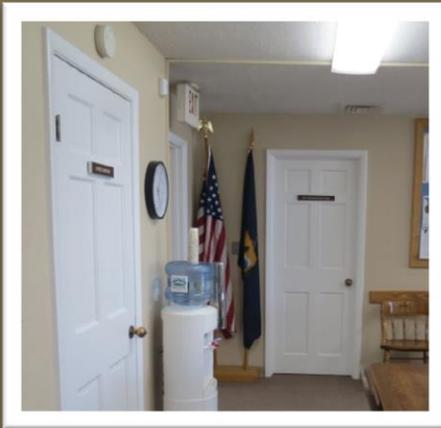
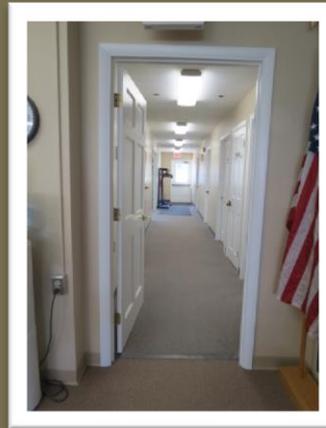
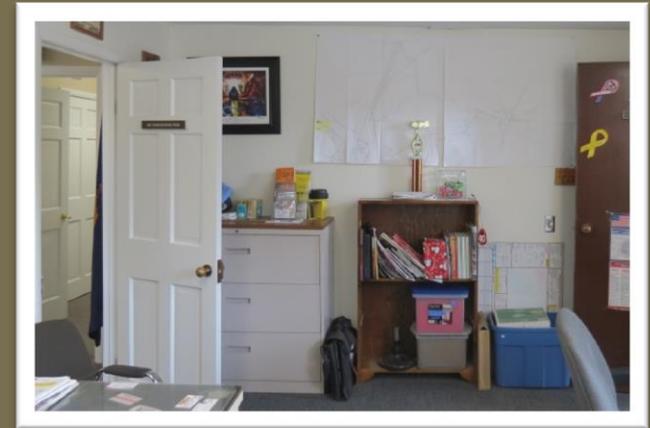
Doors: Sizes, Door Maneuvering Space & Hardware

- Existing 2'-6" wide doors do not meet requirements of a 2'-8" clear opening with the door fully opened.
- The existing doorway separating the accessible hallway and the reception area has a 16" clear space on the pull side of the door, which does not meet the required 18".
- Existing door hardware includes a mix of compliant lever handles and non-compliant knob-type handles.
- Existing door closers do not meet the closing speed for ADA.

- Replace existing 2'-6" doors with 3'-0" doors.
- Move existing doorway at hallway at least 2" so there is a 18" clear space on the pull side of the door.
- Replace existing knob hardware with lever handles, push bars, u-shaped pull handles or other accessible hardware.
- Replace existing door closers with new ADA complaint door closers.

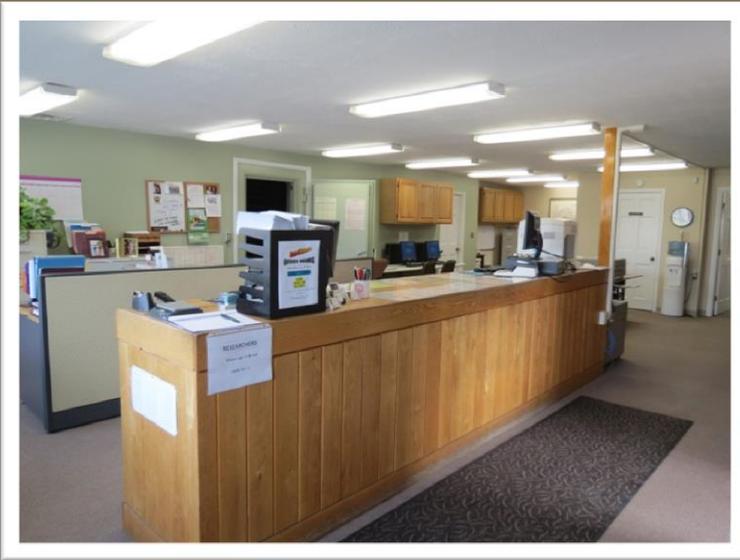
Reception Counter: Accessible Counter Space

- The existing Reception Counter is 42" high and does not provide a section of counter that meets ADA accessible requirements.

- A section of this counter or a fold-down counter needs to be provided for a wheelchair user to be able to transact business and have a writing surface that is at a reasonable height. This should be no more than 36" high and should be at least 36" wide. An accessible service shelf should be at least 19" deep to permit appropriate knee clearance.
- Sales and Service Counters should have a height between 28" and 34" and at least 36" wide.
- An equivalent service area may be provided at a nearby table with sufficient wheelchair clearances.

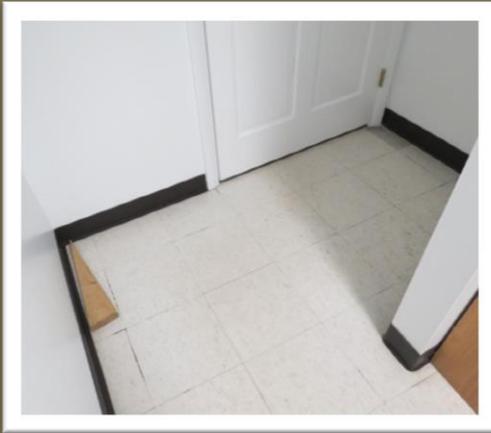
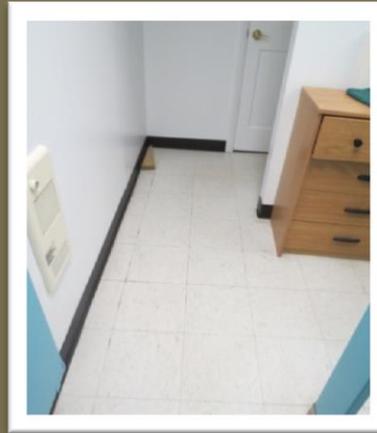
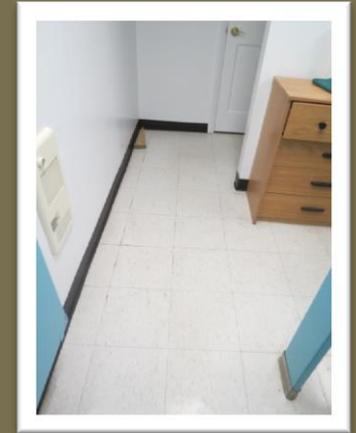
Men's and Women's Bathrooms: Doors Clearances & Maneuvering Space

- The existing privacy wall does not allow 48" clear from the door to the wall and doesn't allow 48" between the end of the privacy wall and the bathroom wall.
- The existing door closers do not meet the required ADA closing speed.
- In the existing bathrooms, a 5'-0" turning radius is not provided

- Remove privacy wall to achieve door clearance requirements and a 5'-0" turning radius
- Replace existing door closer with an ADA compliant closer
- The top of sink to be mounted no more than 34" above floor and exposed piping to insulated and protected
- Provide a 3'-6" and a 3'-0" grab bar at toilet
- Flush valve of toilet to be located on sink side of the toilet
- Mount bottom of mirror no higher than 40" off the floor
- Mount control for towel dispenser or bottom of towel no higher than 48" off the floor
- Mount toilet paper dispenser no more than 9" from the front of the toilet

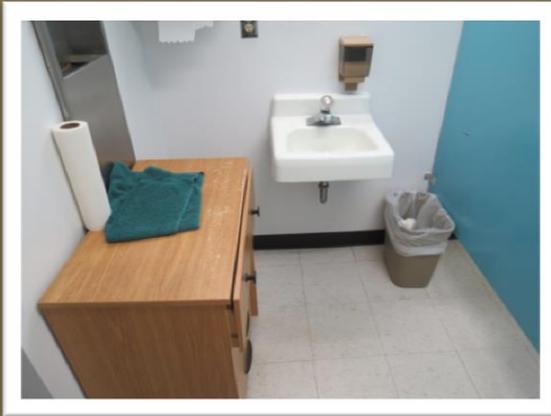
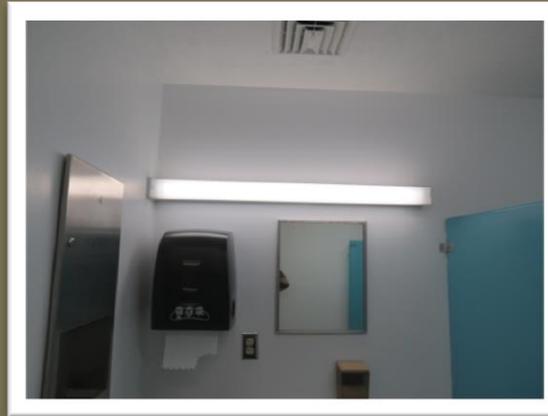
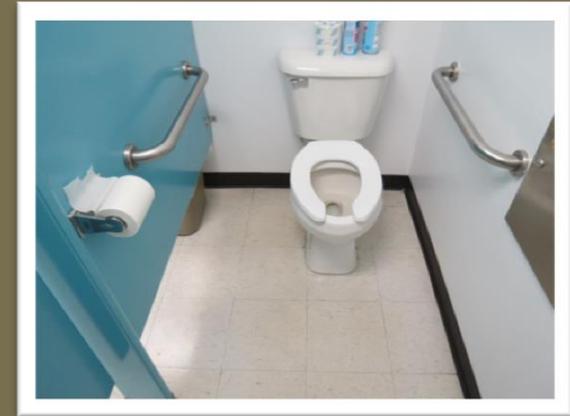
Men's and Women's Bathrooms: Sinks, Mirrors, Paper Towels and Toilet Paper

- The existing wall mounted sinks are mounted to low above the floor and the existing exposed piping under the sink is not insulated and protected
- The existing knob faucets are non-complaint
- The existing mirrors, paper towel dispensers and receptacles are too high off the floor.
- The existing toilet paper dispenser is placed at least 12" away from the front edge of the toilet.

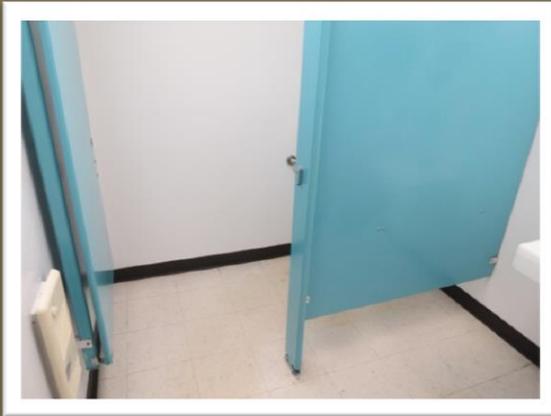
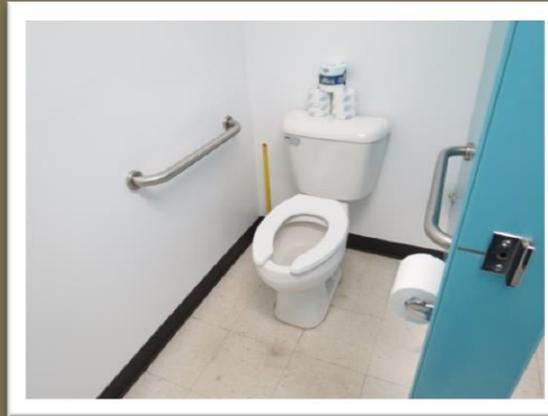
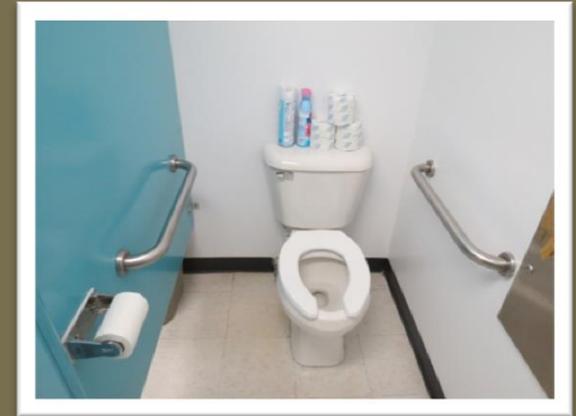
Men's and Women's Bathrooms: Stalls & Toilets

- The existing stall does not meet the minimum size (5'-0" wide by 4'-11" wide)
- The existing grab bars are non-complaint
- The existing stall doors do not provide a minimum of 32" clear door space and the door lock is non-complaint
- The existing flush handle for the toilet is on the wrong side of the toilet.

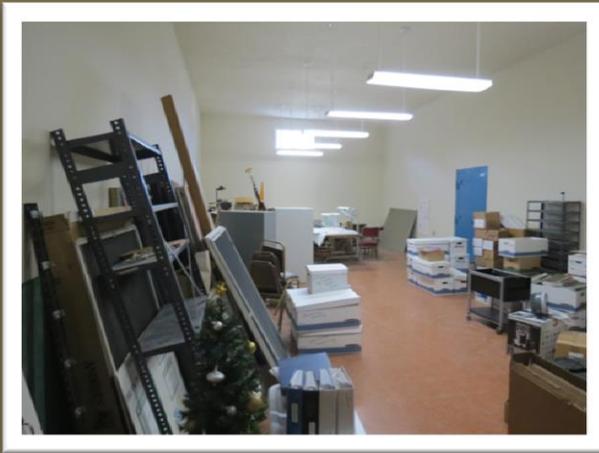
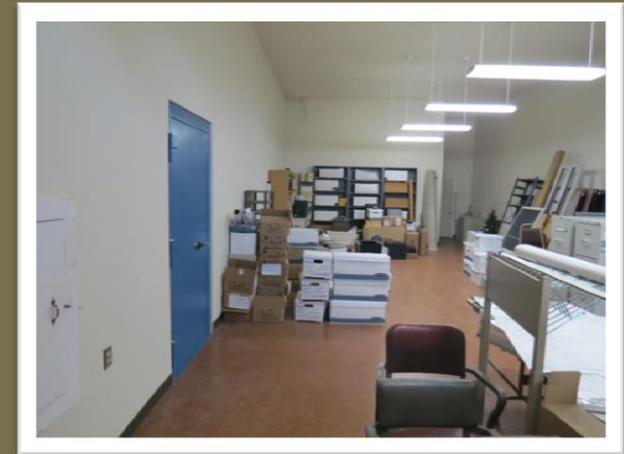
Use of Second Floor: Public Meetings, Private Offices and Means of Egress

- ADA Title II CFP Part 35 – Subpart B – 35.130 – General Prohibitions Against Discrimination , Section 35.130.a states: No qualified person with a disability shall, on the basis of disability, be excluded from participation in or be denied the benefits of the services, programs or activities of a public entity, or be subjected to discrimination by any public entity.

- Provide prefinished birch veneer flush wood solid core doors with narrow vision windows, metal door frames, locksets, door closers and door stops at the Community Center. The doors will be held opened with 120 volt magnetic door holders at each door. New 120 volt photoelectric smoke detectors will be installed on each side of the doors. They will release the door holders upon detection of smoke, allowing the doors to close.
- Provide 120 volt photo-electric smoke detectors in the following areas: One in first floor Hall; one in Town Clerk area; one on second floor at top of stairs and one in future Office on second floor. Interconnect all smoke detectors.
- Provide new code complaint handrails at existing stairs.

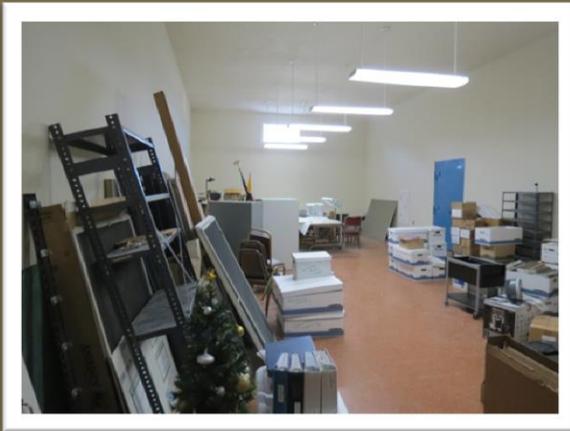
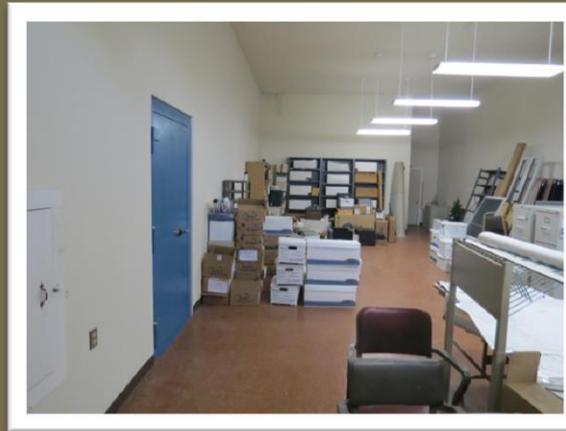
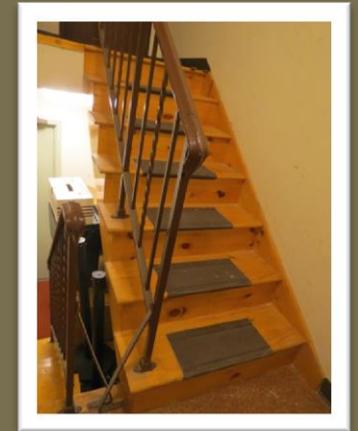
Use of Second Floor: Public Meetings, Private Offices and Means of Egress

- The previous passage in the Title II requirements would affect the second floor since no ADA access is currently provided. Any meeting that can be attended by the public would not be able to occur on an inaccessible floor, since access to any public meeting must be provided to all and any with a disability. Along those lines, any office space that would be used by a town official that interacts with the public would also have to be accessible to anyone with a disability. This would mean that ADA access would have to be provided to the second floor. The code does allow for some flexibility in existing building intending to comply, in this case, providing a separate but equal space.

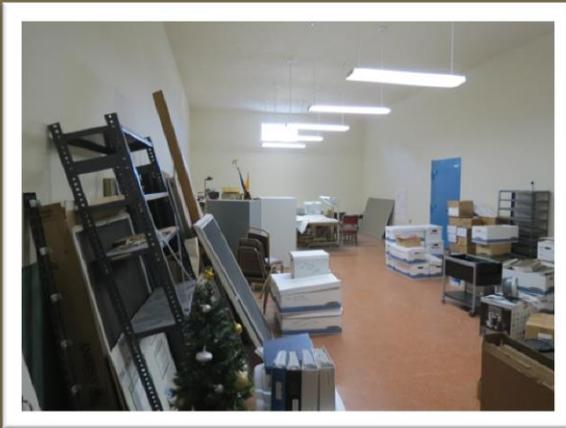
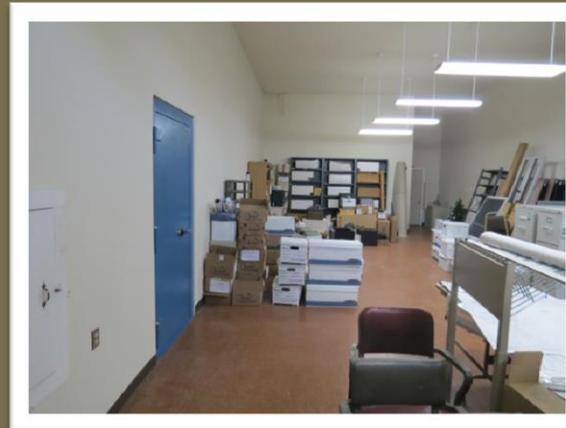
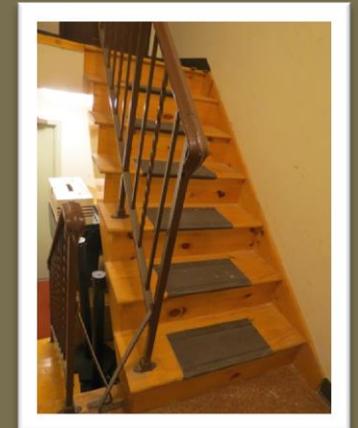
Use of Second Floor: Public Meetings, Private Offices and Means of Egress

- A meeting room could be set up on the accessible first floor that would provide space for a disabled individual to meet with their town official. This meeting room could be communal for all officials on the second floor to use in case of a disabled visitor.
- In order for the second floor to be used as offices, a protected means of egress has to be maintained from the second floor stairs to the exterior of the building.
- The existing railing system is non code complaint with NFPA Life Safety Code
