ARNOLD & SCANGAS

October 20, 2020

We have visually observed the Stinehour Hotel located at 14 St. Armand Street, Highgate, Vermont, to prepare a preliminary conditions diagnostic report. Below are the summarized findings of our site visit. At the end are recommended repairs in order of priority with associated preliminary estimates of probable construction costs.

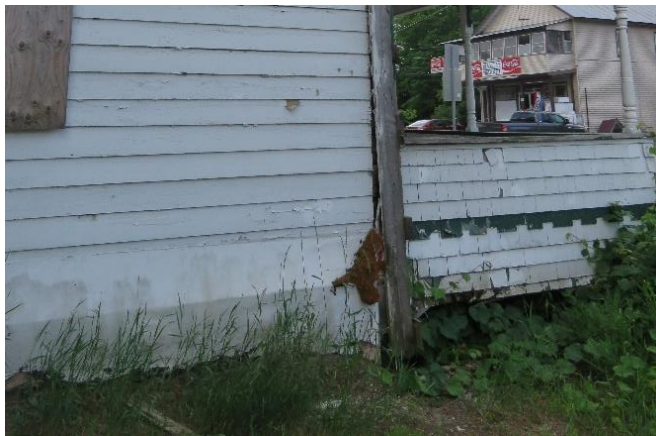
Figure 3 Foundation at Northwest Corner

The original stone foundation is not visible from the exterior. The wrap around porch hides the foundation along the south and west sides of the Main Building and the foundation along the north side of the Main Building has been covered with rigid insulation and asphalt paper that has been painted. The Ell has a stone foundation under the first floor apartment. The rear storage does not have a stone foundation. Observation of this area was limited to views from the exterior through openings in the south doorway.

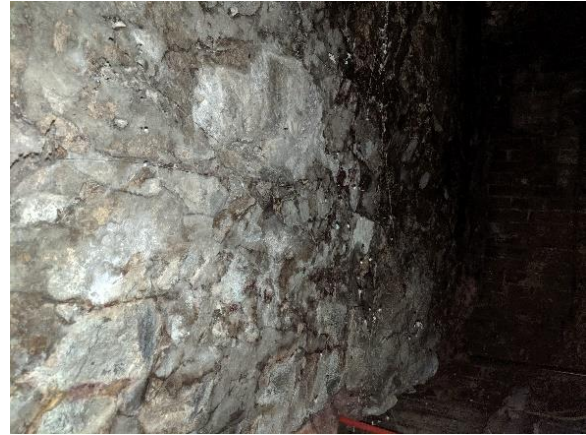
Figure 4 Stone Foundation

Observation of the stone foundation from the basement was limited due to inadequate lighting. The stone foundations appear to be the typical stone masonry of the period and in good condition for its age. Along the west end under the Main Building, there appears to be large stone outcroppings in lieu of a stone foundation. A stone wall separates the Main Building and the rear Ell. The basement had a dirt floor throughout which appeared to be uneven. The stone foundation should be further inspected for any deterioration or water intrusion and repaired. The exterior insulation along the north side of the Main Building should also be removed and the foundation be inspected for damage or deterioration. All interior joints should be examined and all loose mortar should be cleared out and repointed with mortar no harder than the historic mortar.

The structural support of the rear storage should be inspected and replaced with concrete piers extending below the frost line. The heavy timber, wood sill is in poor condition at the northeast corner and has failed. This will need to be replaced and the remaining sills should be inspected and replaced as necessary.

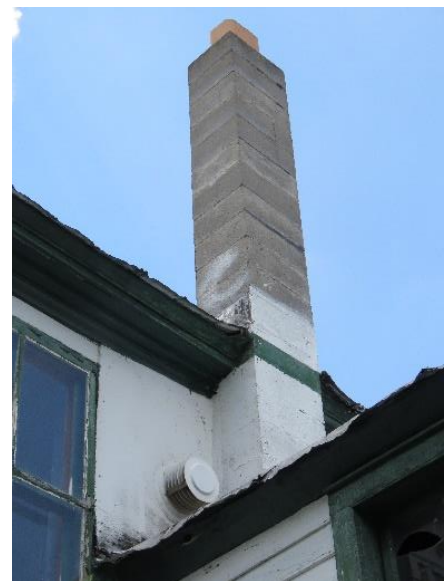
Figure 5 Concrete Block Chimney

The two original chimneys, one at each gable end, as seen in an historical photo from the late 1800's have been removed. A concrete block chimney is on the south side of the Main Building where the southwest corner of the Ell joins the building. This appears to provide venting of the mechanical equipment in the basement. There are some minor cracks in the block but the chimney appears to be in good working condition.

The concrete block chimney should be inspected before being used for future exhaust of the mechanical equipment for any blockage or obstructions.

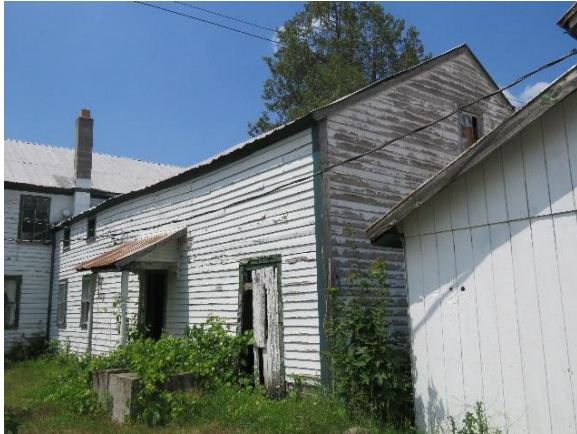
Figure 6 Ell Looking Northwest

The wood clapboards on the Ell portion are in the poorest condition. The south facing façade is similar to the Main Building but shows more signs of damage and peeling paint. The east façade has about 50% of the wood clapboards exposed with no paint but looked dry and in fair condition. The wood clapboards on the north elevation are in very poor condition and in the some areas have been

removed and replaced with wood panels, felt paper or house wrap. This side of the Ell should have all of the clapboards replaced with new wood clapboards. As with the Main Building, the bottom two boards on the south and east sides are also in poor condition and should be replaced. After repairs are made, the remaining clapboards should be scraped, prepped, primed and painted with two finish coats of paint. All new wood clapboards should be primed and painted with two finish coats of paint.

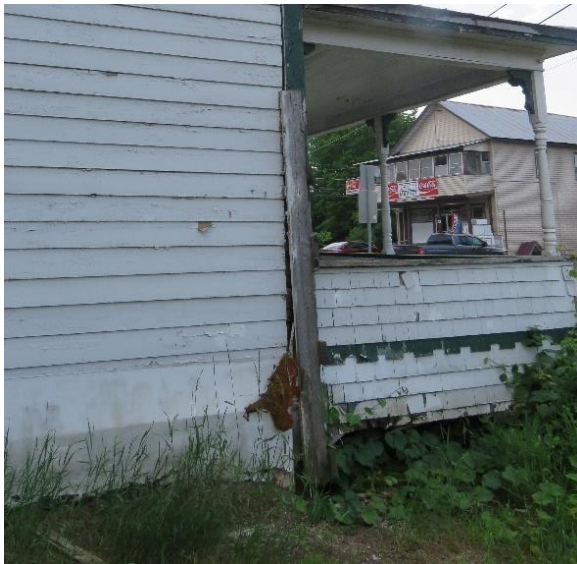
Figure 8 Vertical Corner Board at NW Corner

The vertical corner boards on the Main Building and Ell, plain with no adornment, appear to be in fair to good condition with the exception on the northwest corner of the Main Building. This corner board has rotted and moved away from the building. The corner board should be removed and the structure (wood post) behind it be inspected for damage and rot for possible repair or replacement. After repairs have been made, a new corner board matching the existing should be installed and painted. Remaining corner boards should be scraped, prepped, primed and painted with two finish coats of paint.

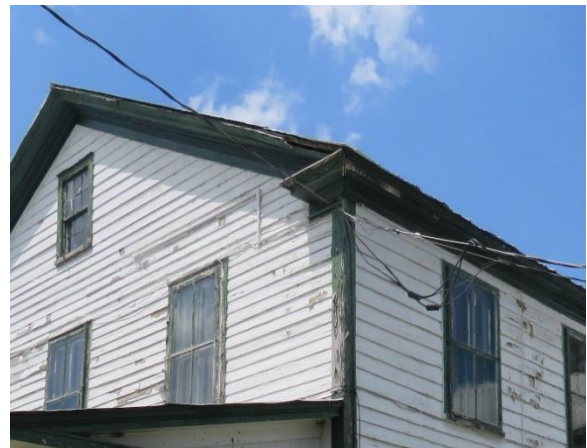
Figure 10 Cornice Return at Southeast Corner

The Main Building has plain, wood boxed cornices, cornice returns and raking cornices with a plain frieze board. Most appear to be in fair to good condition. The southeast cornice return is in poor shape and should be removed and rebuilt to match the existing. There are remnants of gutters on the west side that should be removed. A new gutter is recommended prevent back splashing onto the second floor windows from the porch roof. A leader with a splash block diverting water away from the building should be located on the northwest corner. (This is the corner with the rotting corner board where the original leader was probably located. Care will need to be taken to maintain and prevent any blockage that may cause any future damage to the newly repaired corner.) The sunroom on the southeast of the building is in poor to good condition. The eave board on the south side is in very poor condition and should be removed and replace with a wood eave to match the existing. The rafters at the Ell building are short with no extension and covered with an eave board. The gable end has a rake board flush against the wood clapboard siding and appears to be in fair condition with some visible cracking. This board should be replaced with new wood trim board to batch the existing. The eave board on the south side appears to be in fair to good condition. Estimate that some repairs will be required at the connection with the Main Building. The eave on the north side is in poor to fair condition and should be removed and replaced with new wood trim board to match the existing. Existing wood trim should be scrapped, prepped, primed and painted with two finish coats of paint. The new wood trim board should be primed and painted with two finish coats of paint.

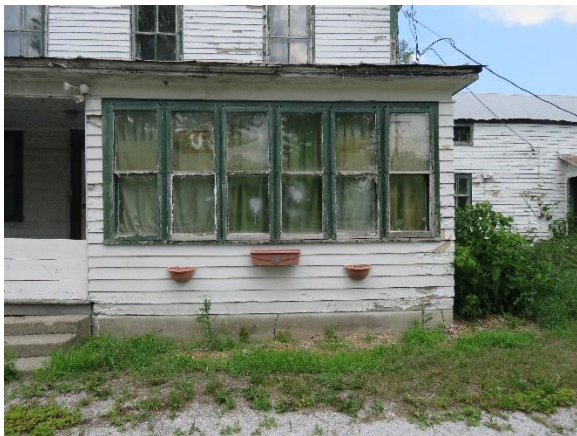
Figure 11 Sunroom at East End of Porch

The sunroom addition on the south side of the Main Building has a concrete foundation with some visible cracks. There was no access to any crawl space to this area. There is no sign of any settlement or drop in the floor. The cracks should be cleaned out and filled to prevent any water intrusion and prevent any further cracking.

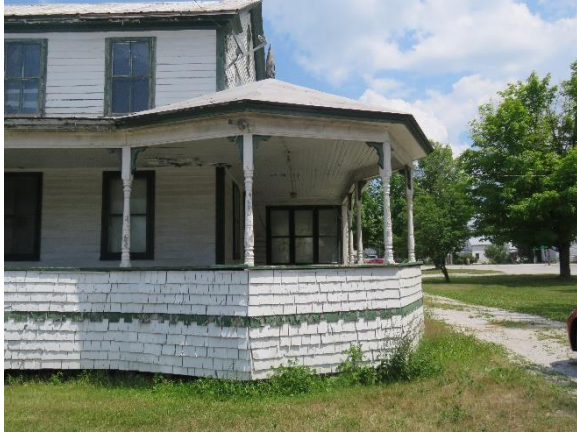
Figure 12 Octagonal Veranda at Porch

The porch has wood shakes on the outside of the knee walls and wood bead board on the inside face. The wood shakes extend to grade with a decorative course of long and short shakes at the floor level. The shakes are in poor to fair condition. When shakes are removed below the floor level, the porch structure and supports should be inspected for damage or rot. The wood bead board on the other side of the knee wall is in fair to good condition. The knee wall is capped with 1x wood between posts that are warped and do not provide proper drainage. The wall caps should be replaced with a new wood or pvc cap designed to drain water to the outside.

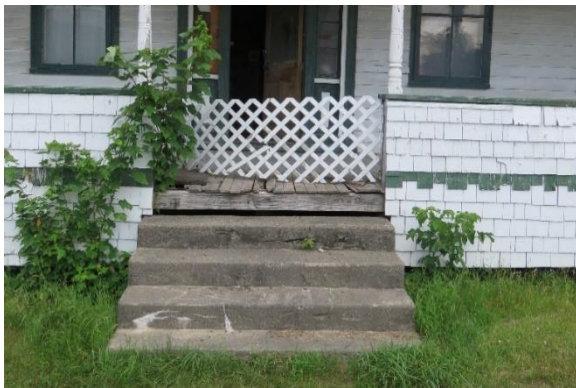
Figure 16 Porch Steps on West Side of Porch

The concrete steps on the west and south sides are in fair to good condition with some cracking. The cracks should be repaired and filled with a patching or mortar mix.

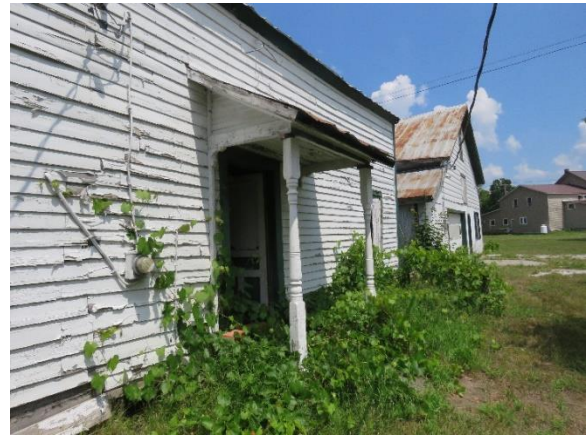
Figure 17 South Entry at Ell

The entrance on the south side of the Ell section is a small shed roof over a few concrete steps supported by two turned wood posts. Plant coverage prevented observation of the steps and bottom of the posts. The wood posts looked in good condition but were poorly supporting the roof. The metal corrugated roof was in fair condition showing signs of age and rusting. The roof should be removed and the underlying structure inspected for damage or rot. The roof structure and posts should be reattached properly and a new metal roof installed similar to the new roof on the wrap-around porch.

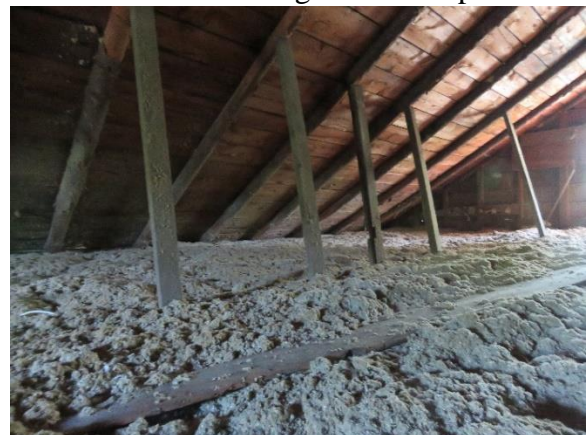
Figure 19 Roof Framing at Main Building

The roof of the Main Building and the Ell have a corrugated metal roof that is rusting and showing signs of age. The roof framing is simple tree trunks spaced about two feet apart with no ridge beam or cross bracing. Random sized boards have been installed on the north side of the Main Building to compensate for structural deficiencies. The roof on the Ell has uneven ridge and eave lines indicating structural problems.

showing the underside of the metal roofing. When the metal roofing is removed, the roofing boards should be inspected for rot or damage and be replaced. New plywood sheathing should be installed over the existing roofing boards to provide a solid surface for new roofing material.

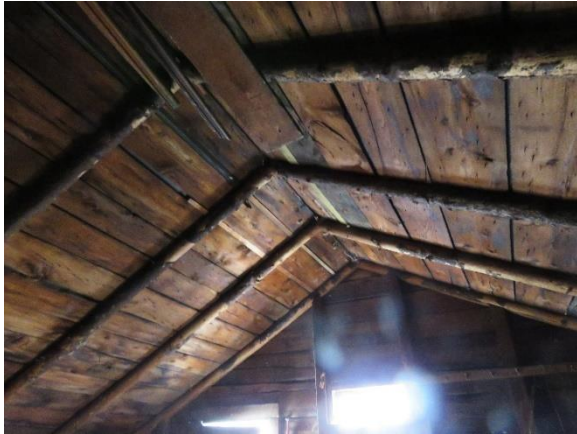
Figure 20 Roof Framing at Ell

The roof of the Main Building and the Ell have a corrugated metal roof that is rusting and showing signs of age. The roof framing is simple tree trunks spaced about two feet apart with no ridge beam or cross bracing. Random sized boards have been installed on the north side of the Main Building to compensate for structural deficiencies. The roof on the Ell has uneven ridge and eave lines indicating structural problems. Some of the exposed roof framing have been fortified with 2x framing attached to the original roof framing. Further investigation by a structural engineer is recommended to determine the current roof live and dead loads and to design additional support to meet current roof loads. The metal roof should be replaced with a new standing seam metal roof or architectural asphalt shingles. The roofing boards in the Main Building look in good condition. The roofing boards in the Ell, however, show signs of water damage and in some places are missing

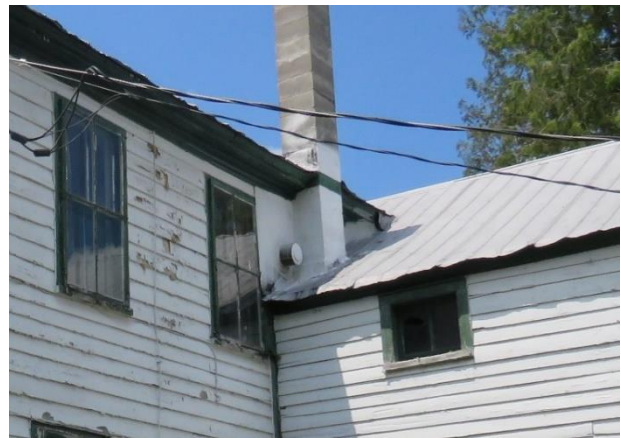
Figure 21 Roof at Main Building and Ell Intersection

The area where the Main Building and the Ell meet on the south side around the chimney has been patched most likely due to water infiltration. When the roof is replaced, this area should be stripped and any underlying structure repaired. The wall should be properly flashed around the chimney and roof junctures and new siding and trim installed.

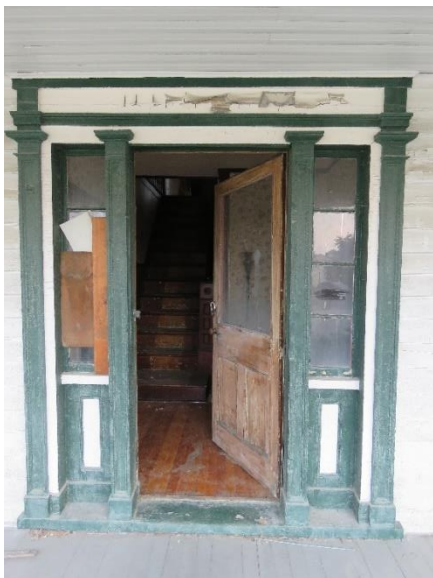
Figure 22 Entry to Main Building

The main entry on the west side of the Main Building is in good condition. The wood entablature and paneled pilasters should be scrapped, prepped and painted. The broken pane in the left sidelight will need to be replaced and both sidelights need to be reglazed. The entry on the south side of the Main Building is similar to the main entry but simpler and without the sidelights. This is in good condition and should be scrapped, prepped

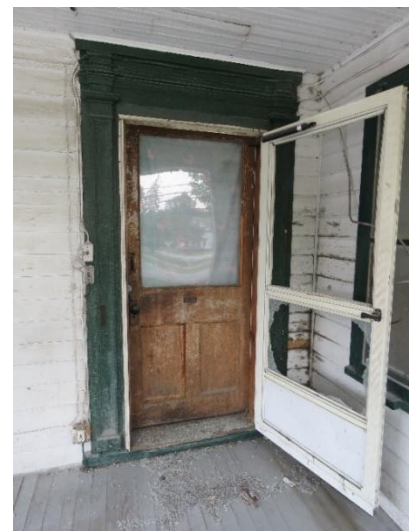
Figure 23 South Entry to Main Building

and painted. The doors at these two entrances are similar with a half glass over two wood panels. The doors have been stripped to bare wood and are in poor condition. The doors should be replaced with new wood doors to match the existing.

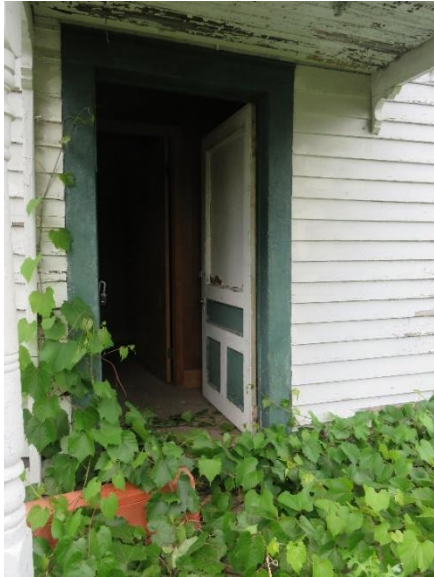
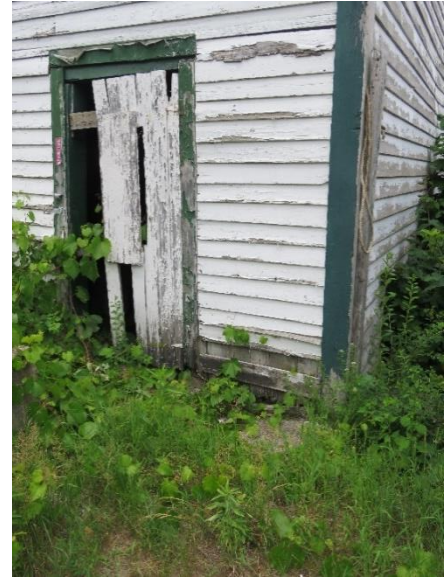
The six doors on the Ell are in very poor to poor condition and should all be replaced. The entry door and north side door of the first floor apartment should be replaced with panel doors matching the period of the building.

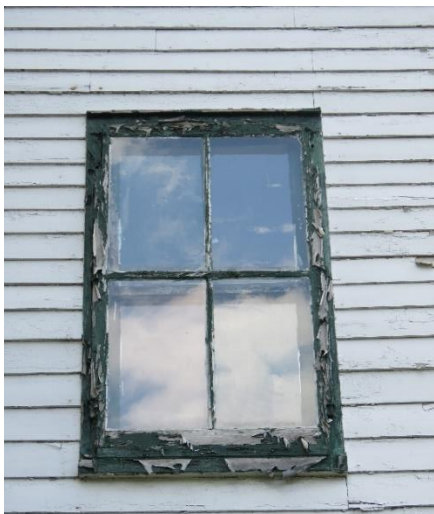
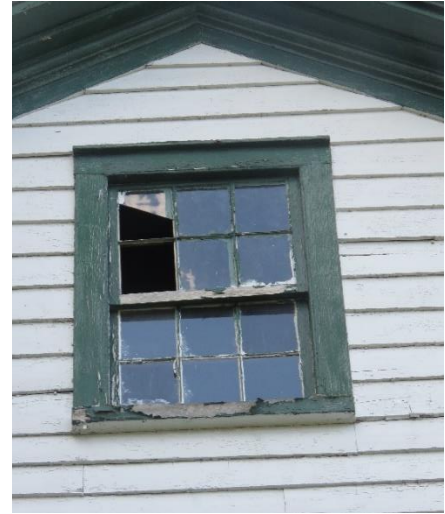
The windows on the building are in poor to fair condition. All of the windows are single glazed with the majority being 2x2. None of the accessible windows were operable. The attic window on

the south side appears to an original window but is in one of the poorest conditions. All of the windows should be replaced with double glazed wood windows to match the existing.

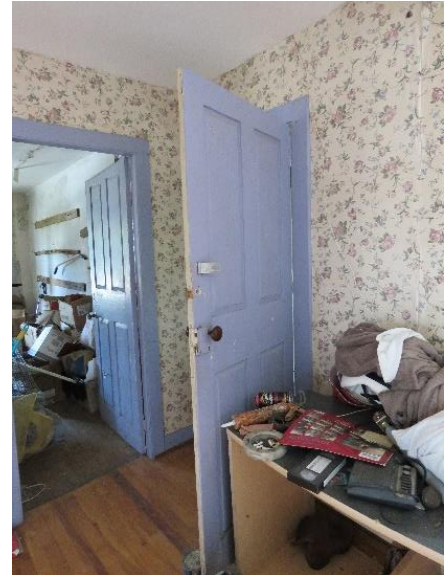
Figure 29 Main Building Second Floor Doors

The interior wood doors in the Main Building are in fair to good condition. The doors on the first floor are six panel doors with the exception of one door leading off the entry to the southwest

room which is a four panel door. The doors on the second floor are four panel doors. The doors should be scraped, prepped and painted or stained. The interior wood doors in the Ell on the second floor vary in style and are in poor to fair condition.

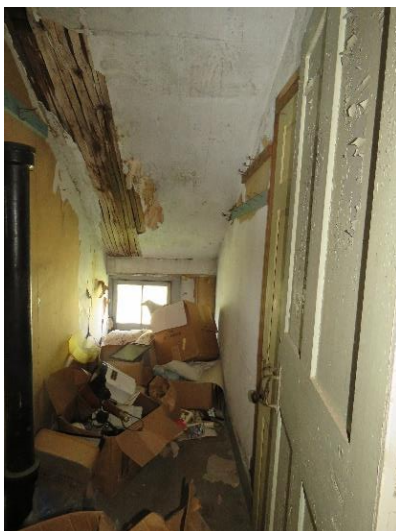
Figure 30 Ell Second Floor Door

Two or three doors appear to be salvageable and should be scrapped, prepped and painted. The interior wood doors on the first floor of the Ell are all modern hollow core doors with the exception of the door leading to the basement which is a four panel wood door. The four panel door can be salvaged and scrapped, prepped and painted or thought should be given to replace this with an insulated door since this leads to an unheated basement. The other doors are not historical and can remain or replaced with doors that are more in keeping with the character of the building.

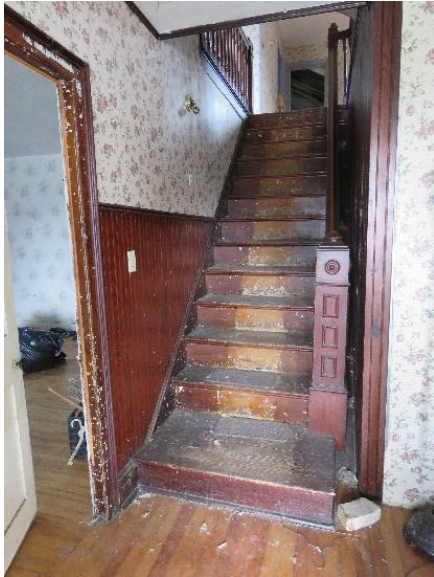
Figure 32 Entry Hall at Main Building

The entry hall in the Main Building leads to two rooms, one on the south side and one on the north side, and a stained wood staircase leading to the second floor. The room has stained wood bead board wainscoting for about 54 inches which is in good condition. The wood wainscoting and stair risers, newel post and trim should be scraped, sanded and stained. The walls above the wainscoting and the ceiling are covered with wallpaper and appear to be in good condition. These surfaces could remain, be re-wallpapered or the wallpaper can be removed and, if needed, the plaster walls can be repaired and painted. The hardwood floor is in fair to good condition and should be sanded and refinished.

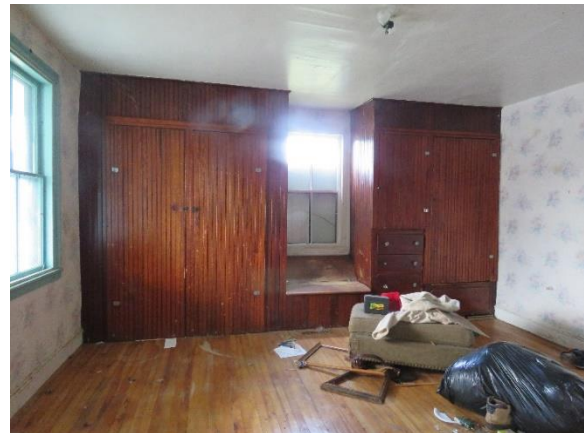
Figure 33 Main Building First Floor NW Room

The northwest room appears to be the “waiting room” and on the north wall

the plaster inspected for repairs. Due to the age of the building, it should be anticipated that the plaster behind the wallpaper may be in poor condition and should be removed to studs and gypsum wallboard installed. The ceiling looks like wallpaper has been installed over plaster or wood bead board. This is usually done to cover damaged surfaces. The ceiling looks to be in fair to good condition and may remain. The interior walls inside the closets are plaster with various layers of wallpaper. The wall paper should be removed and the plaster repaired and/or removed and replaced with gypsum wallboard. The hardwood floor appears to be in fair to good condition and should be sanded and refinished.

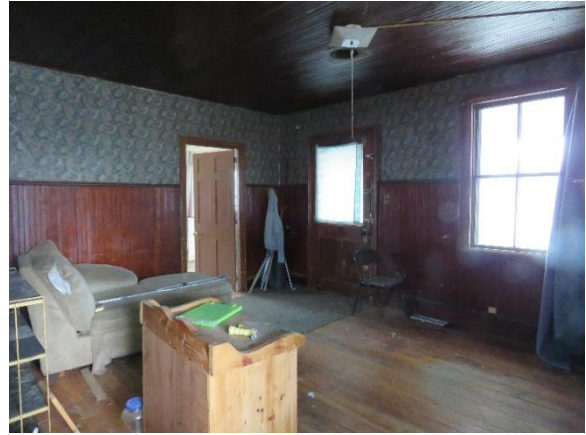
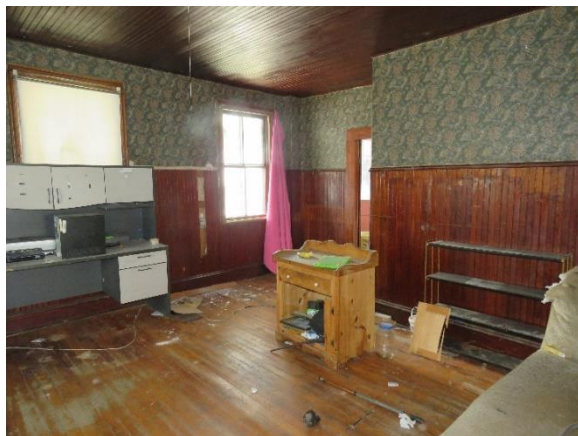
The southwest room has the same stained wood bead board wainscoting found in the entry hall and appears to be in fair to good condition. This should be scraped, sanded and restained. The walls above the wainscoting is covered with wallpaper and appears to be in fair to good condition. Due to the age of the building, it should be anticipated that the plaster behind the wallpaper may be in poor condition and should be removed to studs and gypsum wallboard installed. The ceiling is a stained wood bead board matching the wainscoting. This appears to be in good condition. A hole at the ceiling will need to be infilled with matching bead board and stained. The wood floor appears to be in poor to fair condition with some flooring repair and replacement required. After repairs, the floor should be sanded and refinished.

wall paper should be removed and the plaster walls inspected. It should be anticipated that the plaster is poor condition behind the wallpaper and should be removed to the studs and new gypsum wallboard be installed. The ceiling appears to have a layer of gypsum wallboard installed over the original ceiling. There is a split in the center of the ceiling. This ceiling should be further inspected to see if there is underlying problem with the original ceiling. At a minimum the existing ceiling should be repaired and at worst the ceiling should be removed to framing and a new gypsum wallboard ceiling installed.

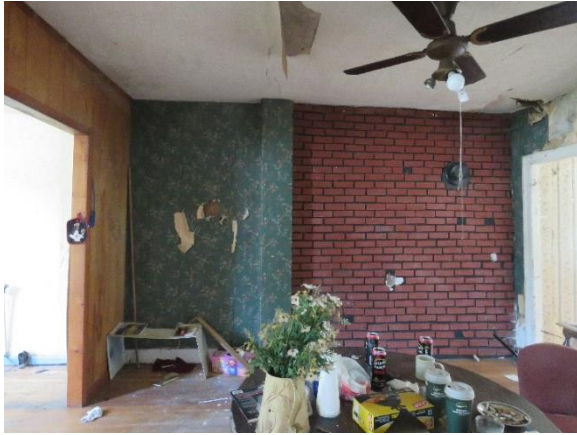
Figure 38 Main Building First Floor Center East Room Looking East

The center section has wallpaper over plaster on the west and south walls. A combination of faux brick and wallpaper over plaster on the east wall and thin wall paneling on the north wall. There is water damage in the southeast corner of the ceiling and wall. A capped stove pipe extends out of the faux brick wall. The ceiling is in poor condition. The wall and ceiling finishes should be removed to the framing and the underlying structure inspected for damage and repairs. A new gypsum wallboard ceiling and walls should be installed. The wood flooring in this area is in fair to good condition with an area in the center with missing boards. New boards should be installed to match the existing and the floor should be sanded and refinished.

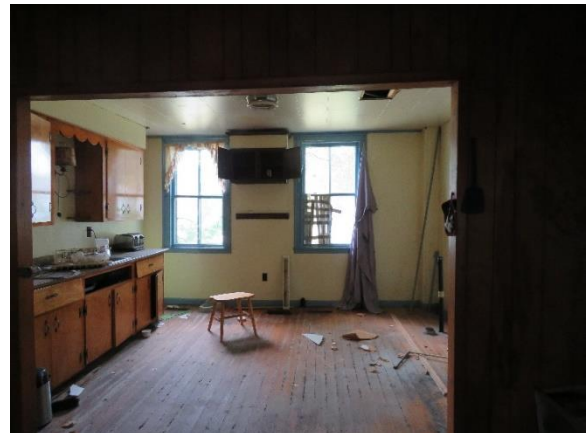
Figure 39 Main Building First Floor NE Room Looking North

The kitchen area in the north section has wood cabinets on the west wall and partial wall cabinets on the north wall. These should be removed. The walls have a thin panel over existing wallpapered plaster indicating that the plaster walls may be in poor condition. The wall materials should be removed to the wood framing and new gypsum wallboard installed. The ceiling has acoustical tile over a dropped wood frame below the existing plaster ceiling that through a hole shows signs of water damage. The ceiling(s) should be removed to the original ceiling and a new gypsum wall board ceiling installed. The wood floor is in poor to fair condition with signs of ant hills between the boards. It is recommended that the floorboards be removed in this area and new floor boards matching adjacent wood flooring be installed.

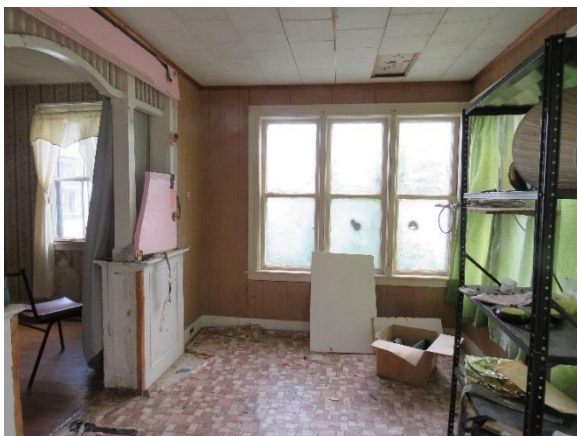
Figure 40 Main Building First Floor Sunroom

The sunroom is a recent enclosure of the southeast corner of the porch. The wall between the sunroom and the adjacent room has a built-in bookshelf and column entrance with a decorative arched opening. This appears to be in fair to good condition and should be cleaned, repaired in some places and painted. The walls in the sunroom are thin wood wall paneling. This should be removed and the wall behind inspected for damage. It is anticipated that the wall finishes will need to be removed to the wood studs and a new gypsum wallboard finish installed. The ceiling is 1x1 acoustical tiles over wood furring over gypsum wallboard. The acoustical ceiling tiles should be removed and the

ceiling above inspected for any damage. If damage is visible, then the gypsum wallboard should be removed and the underlying structure inspected for damage and any damaged areas be repaired. A new gypsum wallboard ceiling then can be installed. The floor appears to be two layers of vinyl sheet flooring in poor condition. This should be removed and a new wood floor installed to match the adjacent room be installed or another new durable surface, such as, tile, linoleum or luxury vinyl planks, installed.

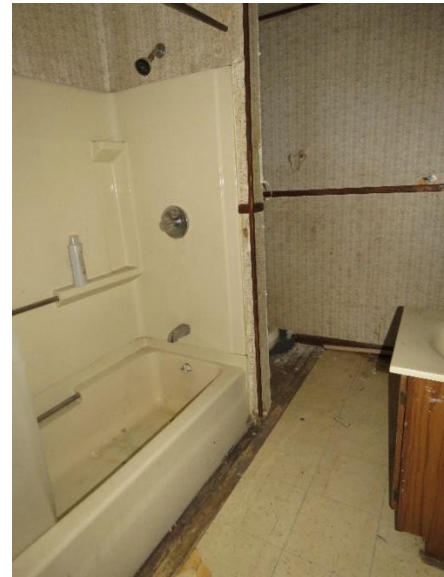
Figure 41 Main Building First Floor Bathroom

There is a bathroom off of the center section to the west with a tub, toilet and vanity sink. This room is very poor shape and should be completely stripped to solid framing. The floor framing should be inspected for damage or rot and repaired as necessary. New floor, wall and ceiling finishes should be installed with new toilet fixtures. A small storage closet is also off of the center section to the west under the stairs. The plaster walls are in poor condition and should be removed to wood framing and replaced with new gypsum wallboard. The floor in the closet is the wood subfloor with no finish. A wood floor matching the adjacent room should be installed.

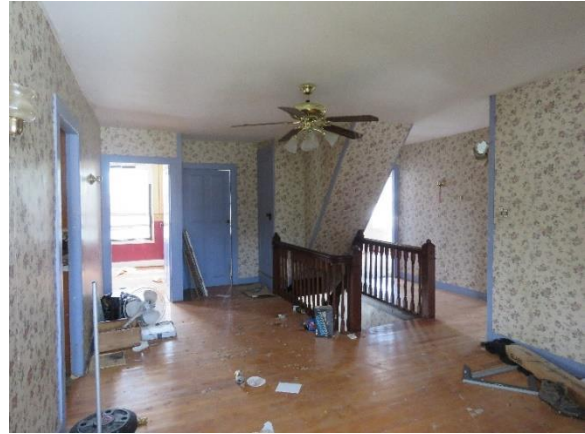
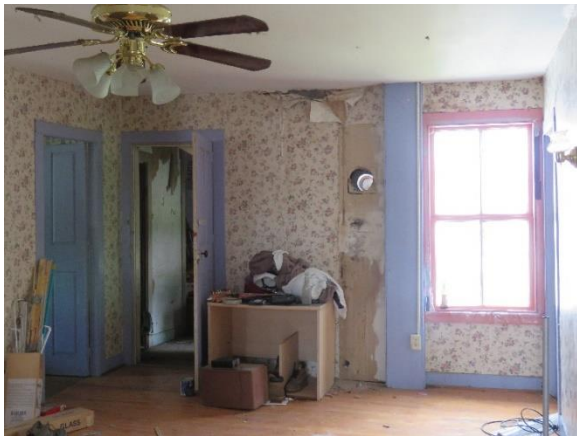
The second floor of the Main Building has some recent renovations. The single stair from the main entry opens to a common room surrounded by seven smaller rooms. A doorway to the south of the stair leads to a stairway to the attic. A doorway on the east side of the room leads to the adjacent Ell building. This room looks to be in good condition. The wood floor has recently been refinished, new wallpaper installed and the doors and wood trim has been painted. The ceiling looks very flat indicating that a new gypsum wallboard ceiling has been installed. The floor should be cleaned and inspected for any repairs or refinishing. The east wall and ceiling has some

water damage and an unfinished area where some kind of heating equipment has been removed. The wall should be stripped in this area and the underlying structure inspected for damage and repairs. The wall vent should be removed and the area patched unless new equipment is installed in this location and the vent location reused.

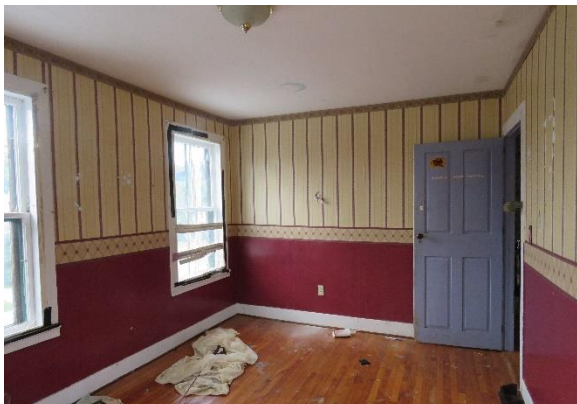
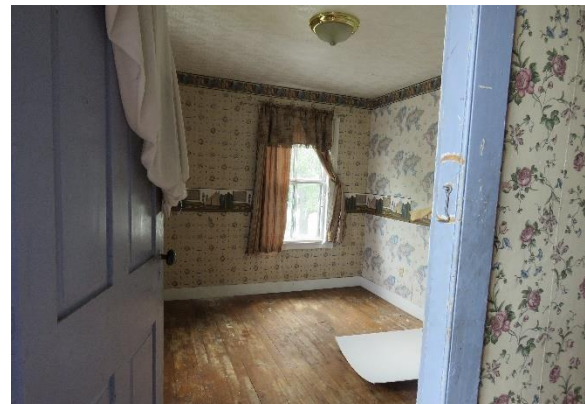
The rooms off of this common room vary in condition. The southwest and southeast corner rooms are in the best condition. The walls have fairly new wallpaper and appear to be in good condition and the ceilings are in good condition. The wood floor in the southwest room has recently been refinished and needs to be cleaned. A missing

portion of wood baseboard should be installed on the east wall. The wood floor in the southeast room is in fair condition and should be sanded and refinished.

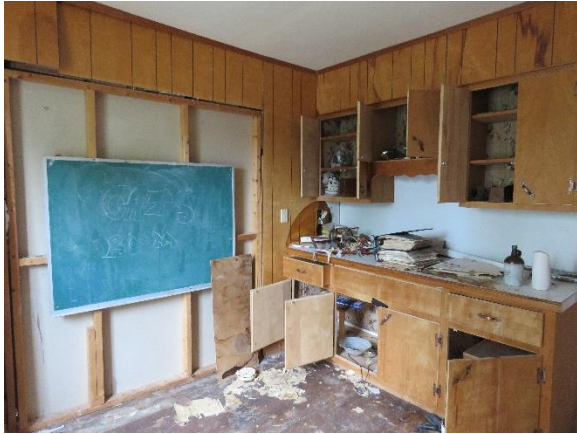
Figure 47 Main Building Second Floor Center South Room

The center room on the south side is a kitchen with cabinets on the north wall. This room is in poor condition. The cabinets are in poor shape and should be removed. The walls have a thin wood panel installed over the original walls and have signs of water damage. These panels should be removed and the walls inspected for condition. It is anticipated that the original plaster walls are in poor condition and should be stripped to the wood framing and new gypsum wallboard be installed. The wood floor is in poor to fair to poor condition. The floor should be inspected for damage and repaired as necessary before being sanded and refinished. The ceiling shows water damage at the light fixture. This area should be removed and the

underlying structure inspected for damage for any necessary repairs. A new gypsum wallboard patch can then be installed.

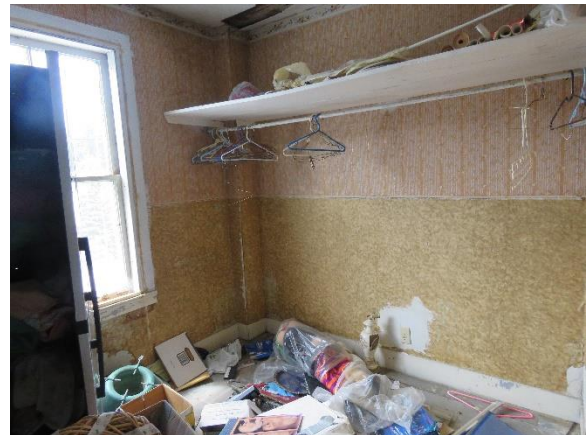
Figure 48 Main Building Second Floor Center West Room

The front center room (above the first floor entry) is a small storage room with plaster walls and ceiling and a wide plank, painted wood floor. The walls and ceiling should be stripped to wood framing and new gypsum wallboard installed. The wood floor was not completely visible but looked in good condition. It should be sanded and refinished.

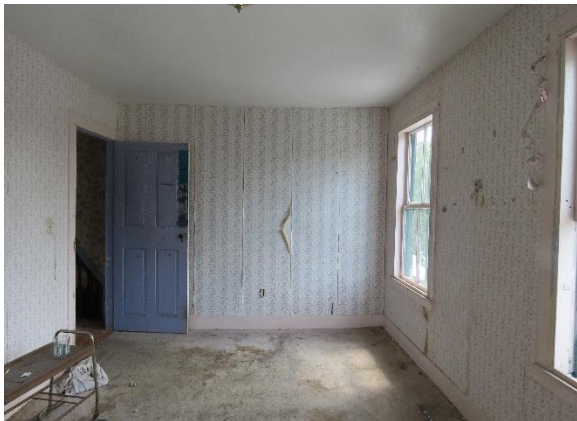
Figure 49 Main Building Second Floor NW Corner Room

The northwest corner room is in fair to good condition. The ceiling looks in good condition. The wallpaper is curling and the seams are highly visible. The finish behind the wallpaper appears to be gypsum wallboard that has possibly been installed over the original plaster. If possible, the

wallpaper should be removed and the wall examined for any necessary repairs. If the wall is in good shape, the gypsum wallboard can be painted. If the wallboard appears to be hiding a problem with the plaster, then the walls should be stripped to the wood framing and new gypsum wallboard be installed. A vent opening in the east wall should be removed and the wall patched and finished. The carpet is in very poor shape and should be removed. It anticipated that the carpet is covering wood flooring typical in the other rooms and will need to be sanded and refinished. If the

carpet is installed over a subfloor, then is recommended that a new wood floor be installed to match the adjacent wood floor.

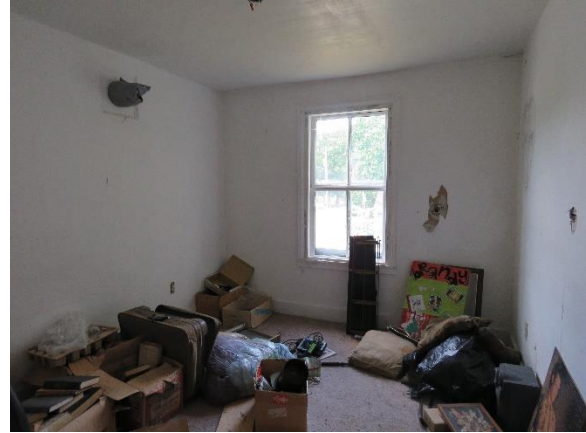
Figure 50 Main Building Second Floor Center North Room

The small center room on the north side is in fair to good condition. The ceiling and walls appear to have a layer of gypsum wallboard over the original plaster and is in fairly good condition. The walls have some damage and require repairing. The vent into the northwest room should be removed and the wall patched. The carpet is in very poor shape and should be removed. It anticipated that the carpet is covering wood flooring typical in the other rooms and will need to be sanded and refinished. If the carpet is installed over a subfloor, then is recommended that a new wood floor be installed to match the adjacent wood floor.

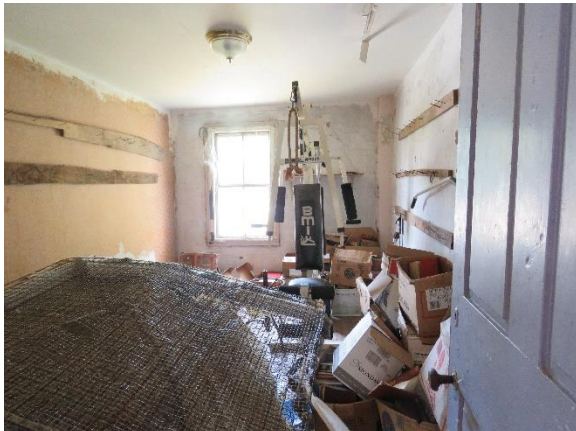
Figure 51 Main Building Second Floor NE Corner Room

The northeast room is in poor to fair shape. The ceiling looks recently refinished with a layer of gypsum wallboard. The walls are the original plaster walls and look in poor to fair condition. The plaster should be removed to wood framing and new gypsum wallboard installed. The wood flooring from what was visible looked to be in fair to good condition and should be stripped, sanded and finished.

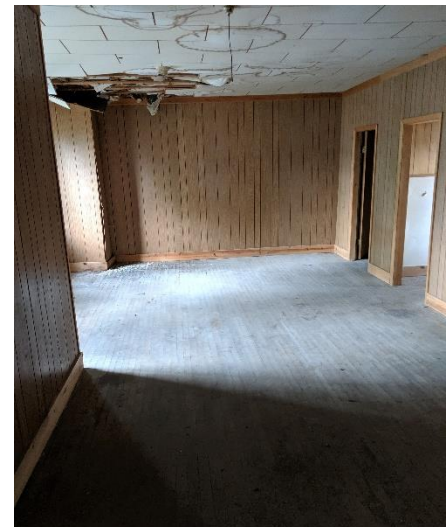
Figure 52 Ell First Floor Apartment

The first floor of the Ell Building is a partially finished apartment. Thin wood paneling has been installed over the existing walls. New wood baseboard, trim and hollow wood doors have been installed. The paneling has areas of damage and warping and was probably installed to hide damaged walls behind it. The paneling should be removed and the wall examined for any damage or repairs. It may be necessary to remove the wall finishes to the wood framing and install new gypsum wallboard. The main room has a 1x2 acoustical tile installed over a dropped wood frame attached to the existing ceiling. There is a large area in the southwest corner damaged from water where acoustical tiles have been removed. This ceiling should be removed to the underlying structure which

should be inspected for damage and necessary repairs. Once any repairs have been made, a new gypsum wallboard ceiling should be installed.

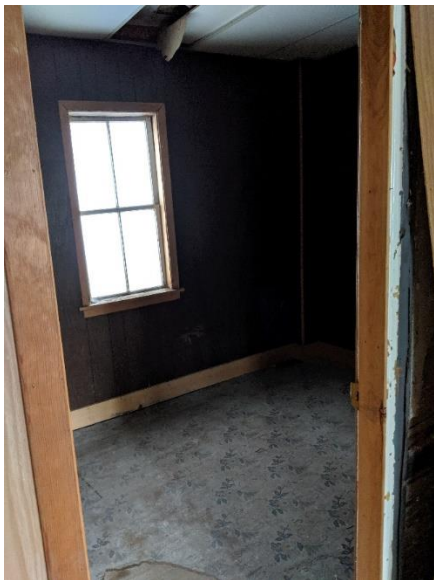
*Figure 54 Ell First Floor Apartment
Center North Room*

The next room to the west has a dropped ceiling and vinyl flooring. The ceiling has some damaged and should be removed to examine the original ceiling above. This ceiling should be removed to the underlying structure which should be inspected for damage and necessary repairs. Once any repairs have been made, a new gypsum wallboard ceiling should be installed. The vinyl floor may of a vintage that contained asbestos and should be tested prior to removal. It appears that there is hardwood floor below the vinyl that can be stripped, sanded and refinished.

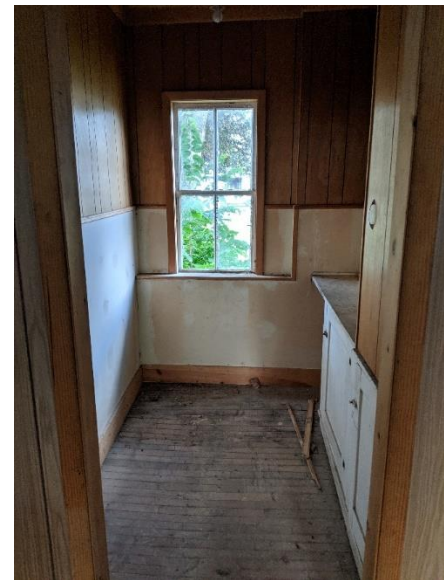
*Figure 55 Ell First Floor Apartment
Pantry*

The next room to the west is a small pantry room. The paneling in this room is above a gypsum wallboard wainscoting. The gypsum wallboard has been taped and mudded but is not finished. The wall should be cleaned and gently sanded before being painted. The wood floor in this room is in poor to fair condition. The floor should be cleaned and examined for any repairs. Once repaired the floor can be stripped, sanded and refinished.

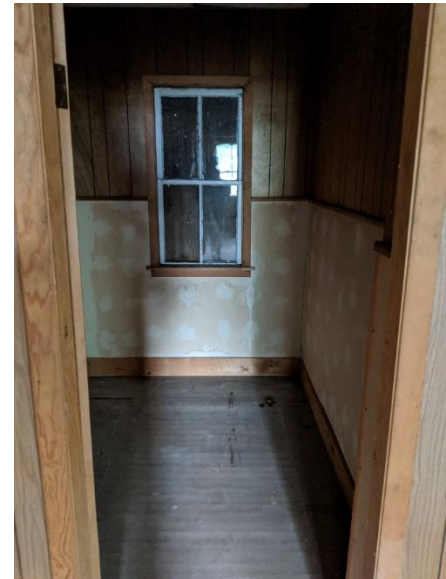
*Figure 56 Ell First Floor Apartment
NW Corner Room*

The last room to the west is a small room with wood paneling over gypsum wallboard wainscoting. The gypsum wallboard has been taped and mudded but is not finished. The wall should be cleaned and gently sanded before being painted. The wood floor in this room is in poor to fair condition. The floor should be cleaned and examined for any repairs. Once repaired the floor can be stripped, sanded and refinished.

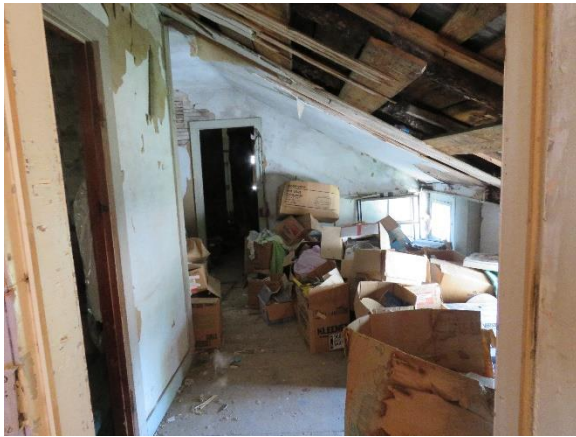
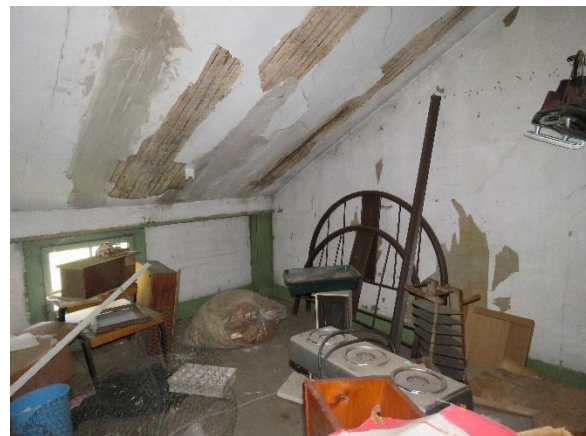
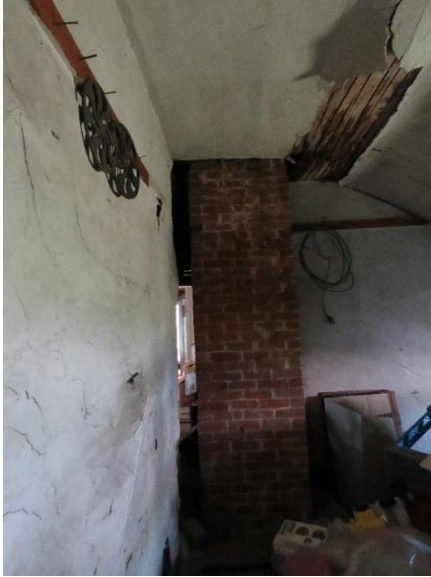
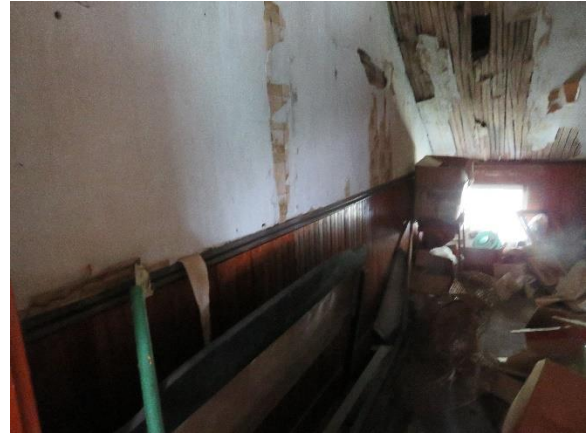
The rooms on the second floor were probably for the hired work and is in a deteriorated condition. This area should be stripped to wood framing and any wood wainscoting salvaged for reinstallation. New gypsum wallboard should be installed and the salvage wainscoting installed in the same locations from where it was removed. The floors are unfinished, wide plank wood boards and appear to be in fair condition and should at the very least be broom cleaned until a future use is determined for this area.

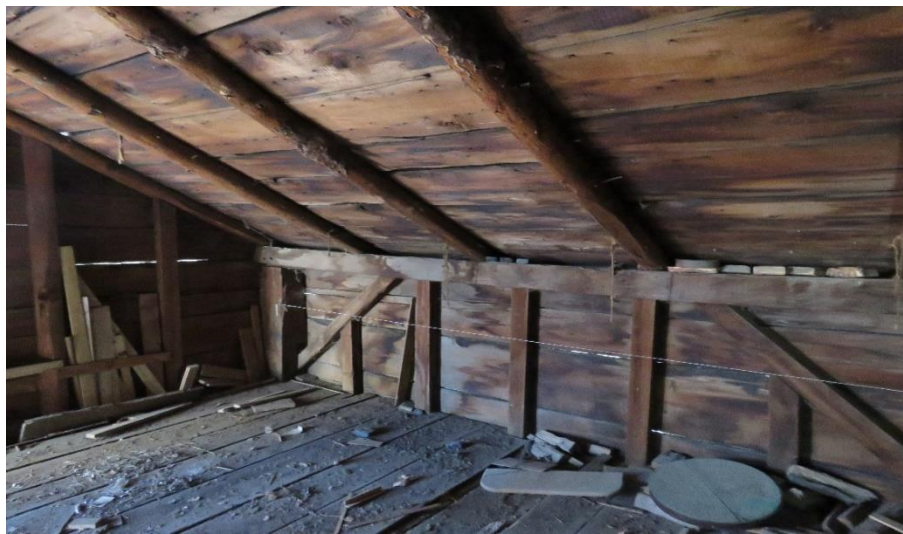
Figure 61 Ell Second Floor East Unfinished Cold Storage

This area leads to an unfinished cold storage area above the first floor cold storage area. The wide plank floor boards are in poor to fair condition. Failing boards should be replaced and the remaining be broom cleaned until a future use is determined.
