Highgate Municipal Building: ADA Compliance Evaluation

ARNOLD & SCANGAS ARCHITECTS

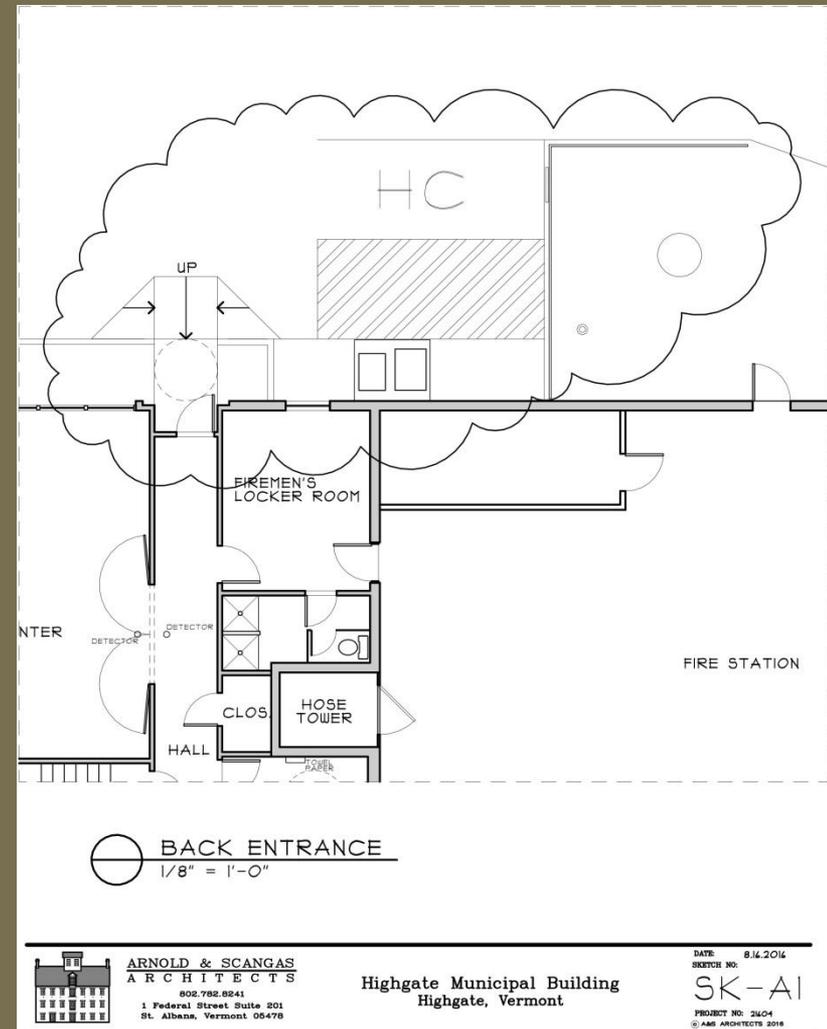
Back Entrance: Solutions

- The space is more than 8' wide which meets the guidelines, but does not provide a marked access aisle of at least 8'-0" wide for van accessible maneuvering
- As currently located, if the access aisle was marked, it would be in the travel lane, which is non-complaint
- The bottom of the accessible sign space designation is 56 1/4" off the ground and does not meet the minimum height of 60" off grade.

- The rear entrance is locked during the day and cannot be use independently during the same business hours as the front entrance.
- The rear entrance does not contain a sign with the international symbol of accessibility, indicating that this is the accessible entrance.
- The landing in front of the exterior entrance is not level and has a number of changes in elevation, the total change in height is approximately 6" from finish floor to top of pavement.
- The existing entrance door at the exterior does not have the required 4'-0" clearance depth.
- The accessible entrance has a curb that protrudes out of the ground more than 1/4"

- Relocate accessible parking space to allow for a van accessible aisle that is not in the designated path of travel
- Provide a “van accessible” sign for the space where the bottom of the sign is at least 60” off grade.
- Reconfigure exterior door landing to allow for a level 5’-0” turning radius landing at doorway.
- Provide a curbed ramp with curb ramp flares
- Provide sign at front entrance stating the accessible entrance is located in the rear of the building.
- Allow accessible entrance to be used independently during regular business hours.
- Provide new sign with the international symbol of accessibility.

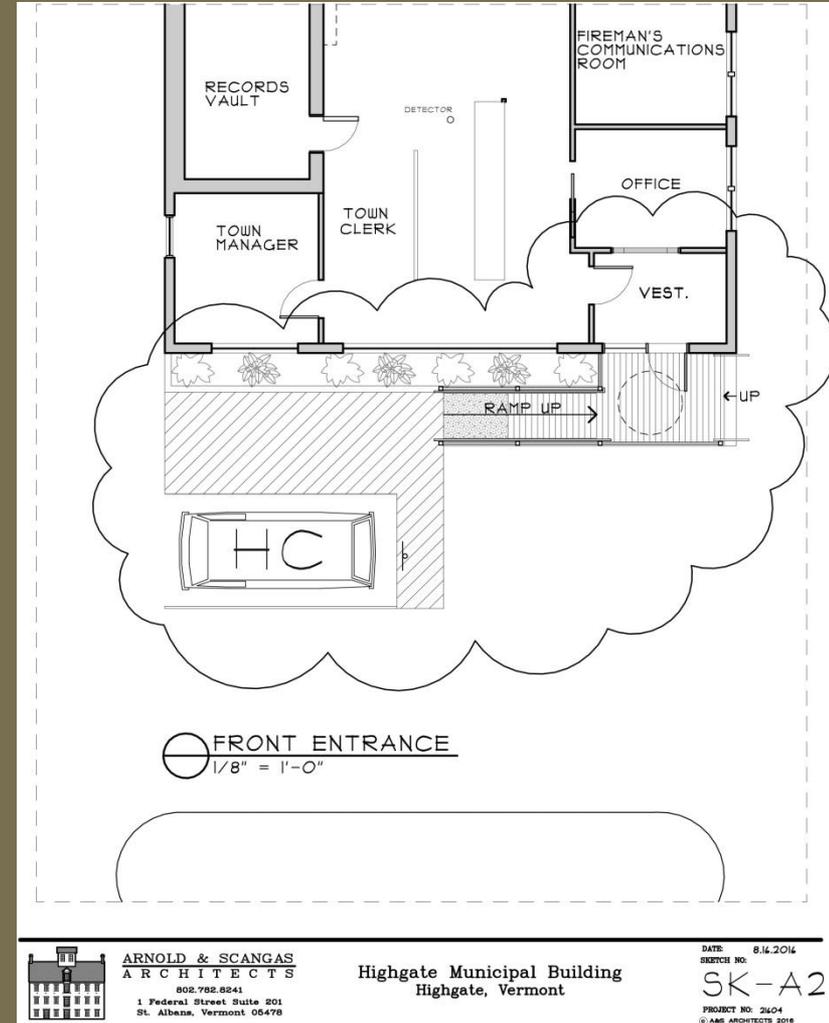
Front Entrance: Solutions

- There is an existing concrete sidewalk that runs along the front of the building. Where the sloping concrete sidewalk meets the pavement there is a change of level that is more than $\frac{1}{2}$ " and is non-complaint
- The existing sidewalk that connects the sidewalk along the building to the landing at the front door, slopes and has a change of level at the front door landing that is more than $\frac{1}{2}$ " and is non-complaint
- While the existing concrete in front of the door is level. There is an approximately 1" vertical change of level at the existing door threshold. A $\frac{3}{4}$ " change is allowed for existing thresholds, however the vertical face on the threshold may not exceed a $\frac{1}{4}$ ", above that height the threshold must be beveled.
- The existing exterior entrance door does not have the required 4'-0" level clearance depth.

- There is an approximately $\frac{3}{4}$ " vertical change of level at the existing exterior door threshold. A $\frac{3}{4}$ " change is allowed for existing thresholds, however the vertical face on the threshold may not exceed a $\frac{1}{4}$ ", above that height thresholds must be beveled.
- The existing interior vestibule does not have a 5'-0" turning radius
- At the interior of the existing vestibule door, there is not the required 1'-6" clearance from the latch side of the door to the corner
- There is an approximately $\frac{1}{2}$ " vertical change of level at the existing interior vestibule door threshold. A $\frac{3}{4}$ " change is allowed for existing thresholds, however the vertical face on the threshold may not exceed a $\frac{1}{4}$ ", above that height thresholds must be beveled.

- Provide a new van accessible parking space including a van accessible aisle
- Provide a “van accessible” sign for the parking space where the bottom of the sign is at least 60” off the grade.
- Provide an accessible ramp with railings from the accessible parking space side and stairs with railings from the fire station side.
- Remove a portion of the exterior vestibule wall to provide the 5’-0” turning radius at the interior of the vestibule and to provide 1’-6” clearance at the pull side of the interior vestibule door.
- Provide new ADA accessible thresholds at both the exterior and interior doors

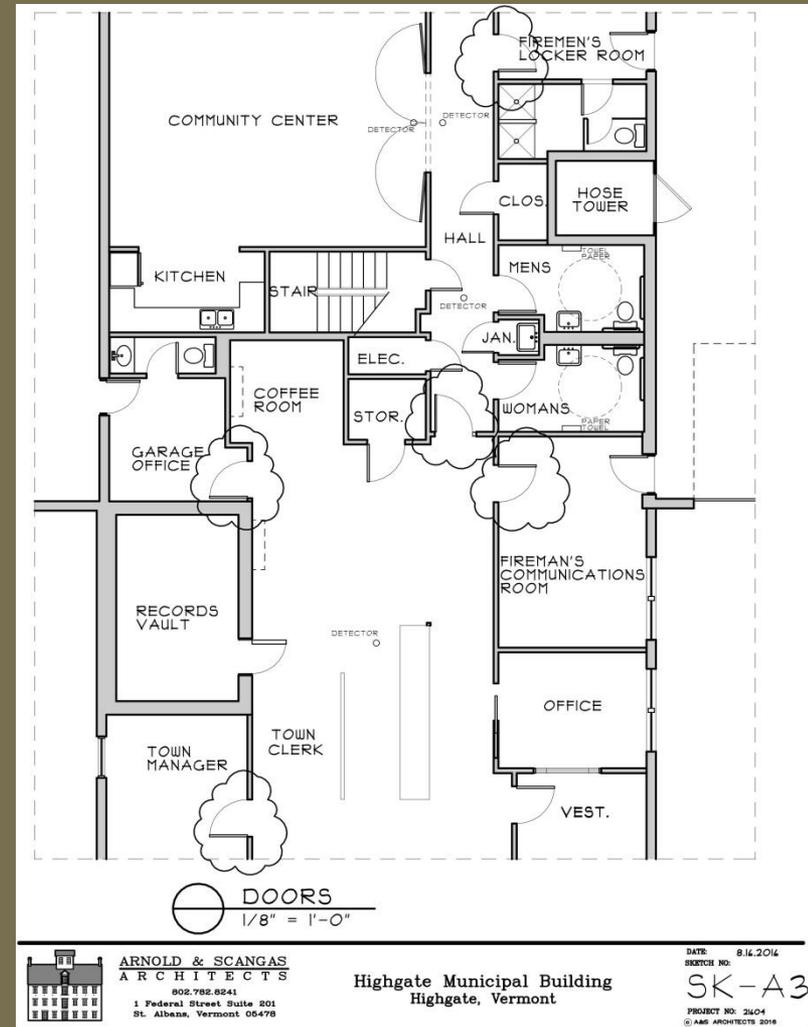
Doors: Solutions

- Existing 2'-6" wide doors do not meet requirements of a 2'-8" clear opening with the door fully opened.
- The existing doorway separating the accessible hallway and the reception area has a 16" clear space on the pull side of the door, which does not meet the required 18".
- Existing door hardware includes a mix of compliant lever handles and non-compliant knob-type handles.
- Existing door closers do not meet the closing speed for ADA.

- Replace existing 2'-6" doors with 3'-0" doors.
- Move existing doorway at hallway at least 2" so there is a 18" clear space on the pull side of the door.
- Replace existing knob hardware with lever handles, push bars, u-shaped pull handles or other accessible hardware.
- Replace existing door closers with new ADA complaint door closers.

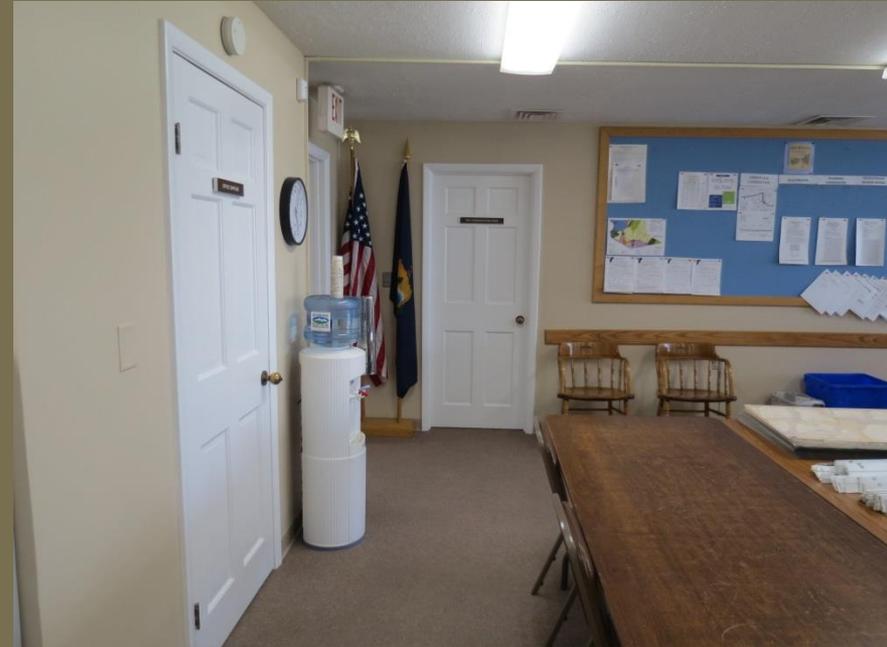
Reception Counter: Solutions

- The existing Reception Counter is 42" high and does not provide a section of counter that meets ADA accessible requirements.

- A section of this counter or a fold-down counter needs to be provided for a wheelchair user to be able to transact business and have a writing surface that is at a reasonable height. This should be no more than 36" high and should be at least 36" wide. An accessible service shelf should be at least 19" deep to permit appropriate knee clearance.
- Sales and Service Counters should have a height between 28" and 34" and at least 36" wide.
- An equivalent service area may be provided at a nearby table with sufficient wheelchair clearances.

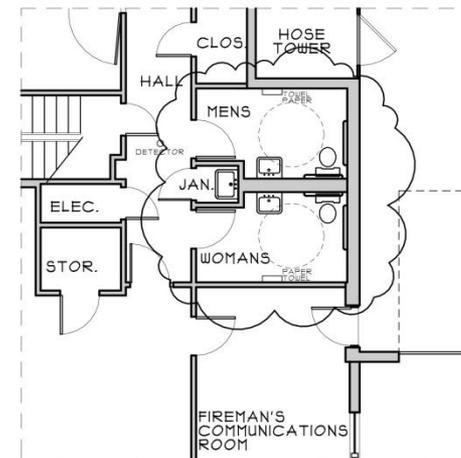
○ MEN'S & WOMAN'S BATHROOM
1/8" = 1'-0"

- The existing privacy wall does not allow 48" clear from the door to the wall and doesn't allow 48" between the end of the privacy wall and the bathroom wall.
- The existing door closers do not meet the required ADA closing speed.
- In the existing bathrooms, a 5'-0" turning radius is not provided

- The existing wall mounted sinks are mounted to low above the floor and the existing exposed piping under the sink is not insulated and protected
- The existing knob faucets are non-complaint
- The existing mirrors, paper towel dispensers and receptacles are too high off the floor.
- The existing toilet paper dispenser is placed at least 12" away from the front edge of the toilet.

- The existing stall does not meet the minimum size (5'-0" wide by 4'-11" wide)
- The existing grab bars are non-complaint
- The existing stall doors do not provide a minimum of 32" clear door space and the door lock is non-complaint
- The existing flush handle for the toilet is on the wrong side of the toilet.

- Remove privacy wall to achieve door clearance requirements and a 5'-0" turning radius
- Replace existing door closer with an ADA compliant closer
- The top of sink to be mounted no more than 34" above floor and exposed piping to insulated and protected
- Provide a 3'-6" and a 3'-0" grab bar at toilet
- Flush valve of toilet to be located on sink side of the toilet
- Mount bottom of mirror no higher than 40" off the floor
- Mount control for towel dispenser or bottom of towel no higher than 48" off the floor
- Mount toilet paper dispenser no more than 9" from the front of the toilet

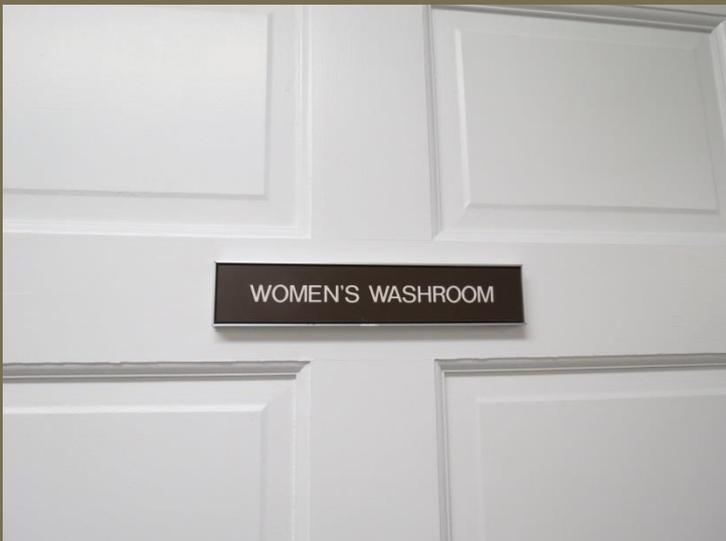
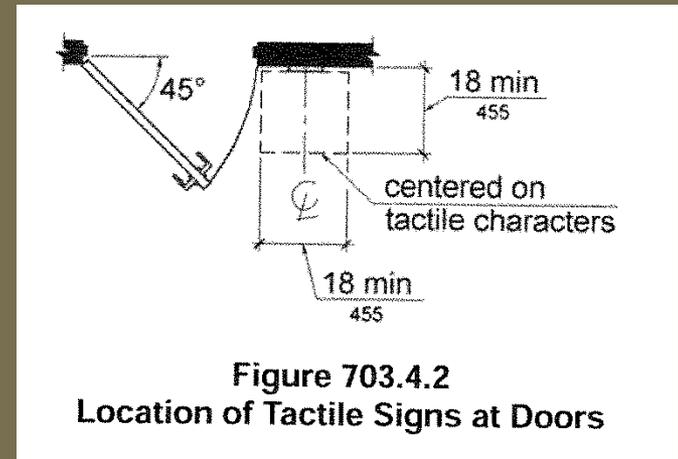
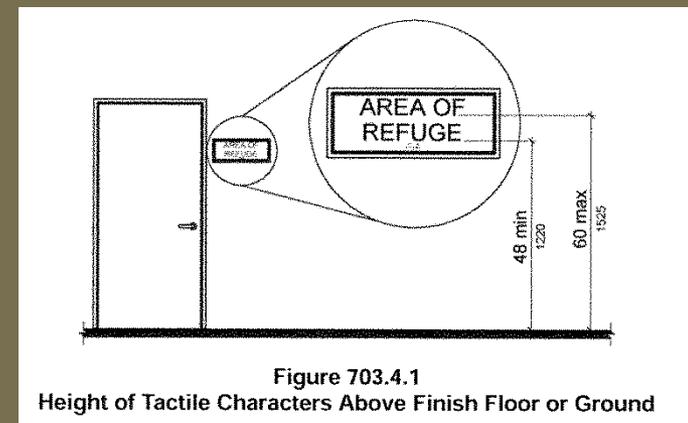
- There is no ADA complaint informational signage present in the building.

- Provide Signage to comply with ADA regulations. Informational signage should be located to the latch side of the door at a height of 62” above the finish floor.
- A minimum of three signs are required, one for each of the Bathrooms and for the Community Room

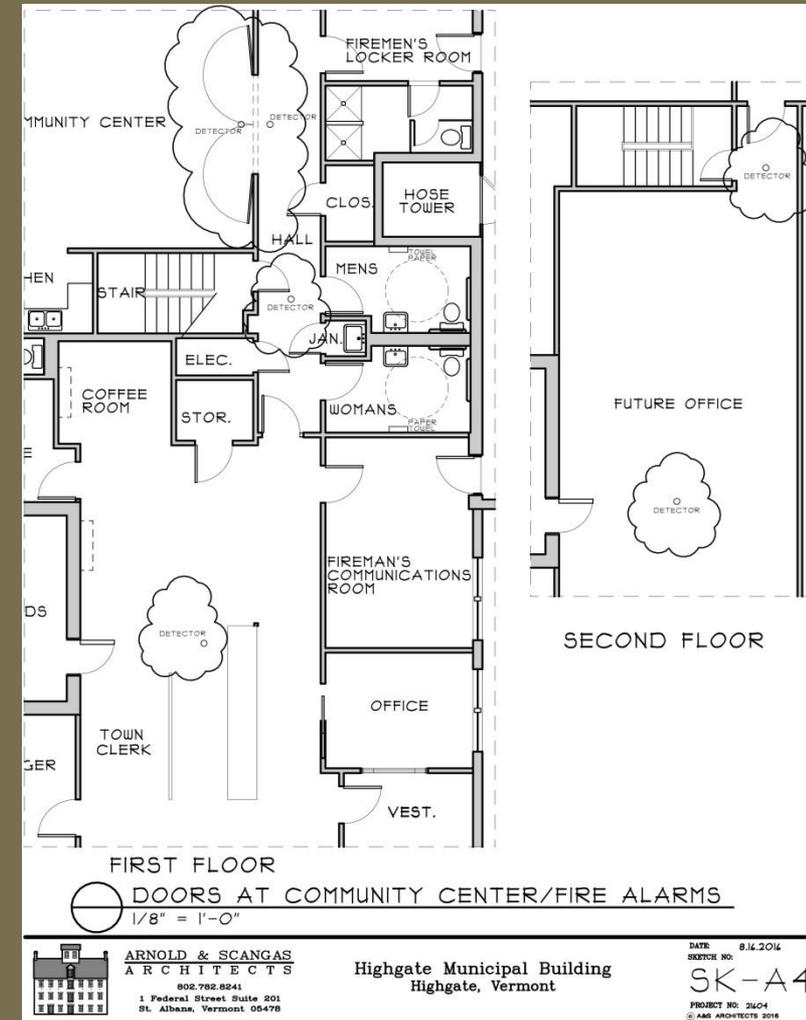
Use of Second Floor: Solutions

- The previous passage in the Title II requirements would affect the second floor since no ADA access is currently provided. Any meeting that can be attended by the public would not be able to occur on an inaccessible floor, since access to any public meeting must be provided to all and any with a disability. Along those lines, any office space that would be used by a town official that interacts with the public would also have to be accessible to anyone with a disability. This would mean that ADA access would have to be provided to the second floor. The code does allow for some flexibility in existing building intending to comply, in this case, providing a separate but equal space.

- A meeting room could be set up on the accessible first floor that would provide space for a disabled individual to meet with their town official. This meeting room could be communal for all officials on the second floor to use in case of a disabled visitor.
- In order for the second floor to be used as offices, a protected means of egress has to be maintained from the second floor stairs to the exterior of the building.
- The existing railing system is non code complaint with NFPA Life Safety Code

- Provide prefinished birch veneer flush wood solid core doors with narrow vision windows, metal door frames, locksets, door closers and door stops at the Community Center. The doors will be held opened with 120 volt magnetic door holders at each door. New 120 volt photoelectric smoke detectors will be installed on each side of the doors. They will release the door holders upon detection of smoke, allowing the doors to close.
- Provide 120 volt photo-electric smoke detectors in the following areas: One in first floor Hall; one in Town Clerk area; one on second floor at top of stairs and one in future Office on second floor. Interconnect all smoke detectors.
- Provide new code complaint handrails at existing stairs.

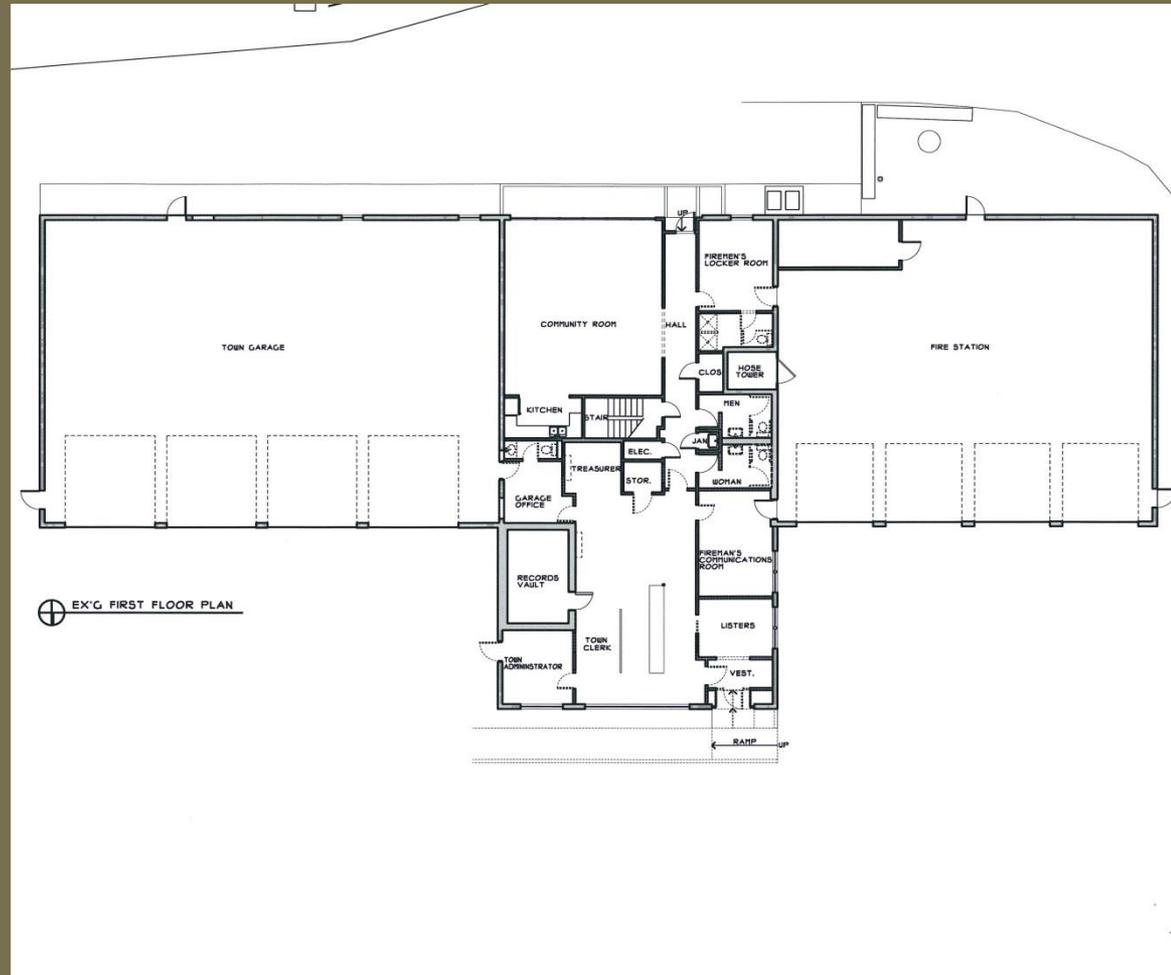
Masterplan: Existing

- Back Entrance
- Front Entrance
- Door, Sizes, Door Maneuvering Space and Hardware
- Reception Counter
- Men's and Women's Bathrooms
- Signage
- Provide adequate room for employees
- Main office flow is clumsy and noisy
- Listers office is small
- Treasurer does not have an office
- Fire Department has a large office
- Town Garage office and bathroom
- Town Garage work/breakrm in garage
- Town Garage needs additional storage
- Fire Department locker room and bath/showers
- Files stored in community room
- Exterior door at Town Administrator's office, remove or replace
