ARNOLD & SCANGAS

October 20, 2020

We have visually observed the Stinehour Hotel located at 14 St. Armand Street, Highgate, Vermont, to prepare a preliminary conditions diagnostic report. Below are the summarized findings of our site visit. At the end are recommended repairs in order of priority with associated preliminary estimates of probable construction costs.

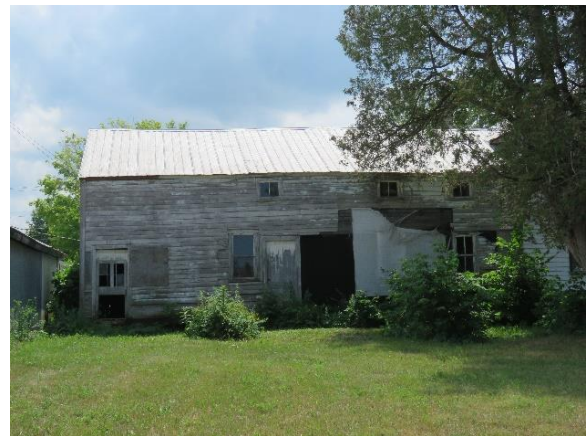
Figure 7 Ell Looking South

The wood clapboards on the Ell portion are in the poorest condition. The south facing façade is similar to the Main Building but shows more signs of damage and peeling paint. The east façade has about 50% of the wood clapboards exposed with no paint but looked dry and in fair condition. The wood clapboards on the north elevation are in very poor condition and in the some areas have been

removed and replaced with wood panels, felt paper or house wrap. This side of the Ell should have all of the clapboards replaced with new wood clapboards. As with the Main Building, the bottom two boards on the south and east sides are also in poor condition and should be replaced. After repairs are made, the remaining clapboards should be scraped, prepped, primed and painted with two finish coats of paint. All new wood clapboards should be primed and painted with two finish coats of paint.

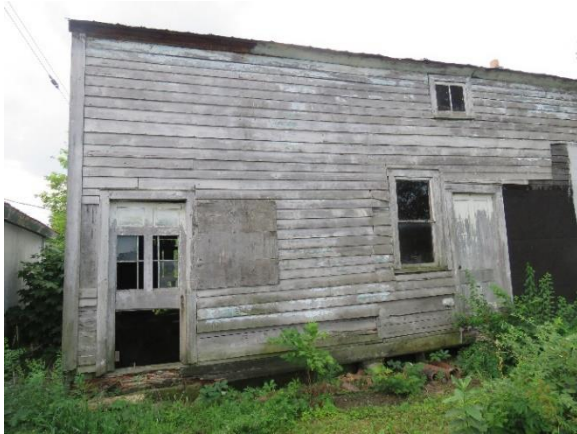
Figure 9 Ell Looking South

exposing the wood. The wood casings on the north side of the Ell are completely exposed with no paint and are in poor to fair condition. They should be replaced to match the existing. The wood casings at the south and east doorways leading into the cold storage areas on the first floor and second floor of the Ell are in poor to fair condition and should also be replaced to match the existing. Existing wood casings should be scrapped, prepped, primed and painted with two finish coats of paint. The new wood casings should be primed and painted with two finish coats of paint.

The eave board on the south side is in very poor condition and should be removed and replace with a wood eave to match the existing. The rafters at the Ell building are short with no extension and covered with an eave board. The gable end has a rake board flush against the wood clapboard siding and appears to be in fair condition with some visible cracking. This board should be replaced with new wood trim board to batch the existing. The eave board on the south side appears to be in fair to good condition. Estimate that some repairs will be required at the connection with the Main Building. The eave on the north side is in poor to fair condition and should be removed and replaced with new wood trim board to match the existing. Existing wood trim should be scrapped, prepped, primed and painted with two finish coats of paint. The new wood trim board should be primed and painted with two finish coats of paint.

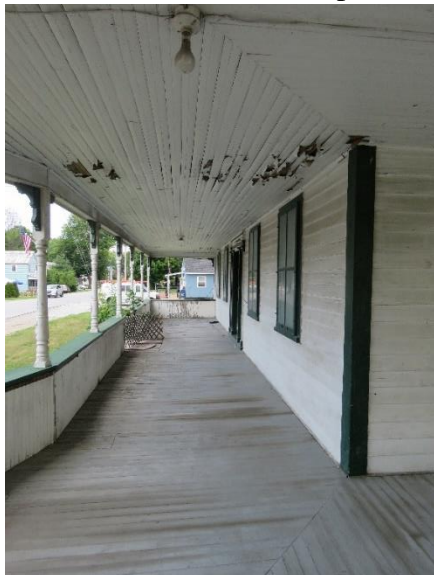
Figure 14 Porch Looking North

The porch has wood shakes on the outside of the knee walls and wood bead board on the inside face. The wood shakes extend to grade with a decorative course of long and short shakes at the floor level. The shakes are in poor to fair condition. When shakes are removed below the floor level, the porch structure and supports should be inspected for damage or rot. The wood bead board on the other side of the knee wall is in fair to good condition. The knee wall is capped with 1x wood between posts that are warped and do not provide proper drainage. The wall caps should be replaced with a new wood or pvc cap designed to drain water to the outside.

The wood T&G decking is in fair to good condition. In many places the paint is worn off or peeling. Sections of the decking have been replaced in front of both set of steps and are in the poorest condition. The sections need to be removed and the underlying structure examined for any damage or rot. Additional boards around these areas should be removed so that new boards will be feathered into the existing boards. There is no drainage openings in the knee wall to allow rain or snow melt to drain off the porch. This may be why

the floor decking is in such bad

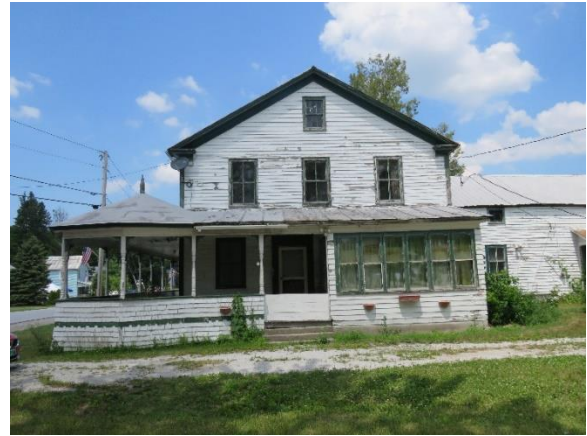
Figure 15 Main Building Looking North

A metal corrugated roof extends across the west and south sections of the porch roof with a flat metal roof over the octagonal veranda. The metal roof is in fair condition and should be replaced. The bottom two courses of clapboard on the Main Building should be removed and new wall flashing installed. A new kynar finish, standing seam metal or aluminum roof should be installed that will withstand water and snow melt from the upper roof. The fascia board around the perimeter of the roof is in poor to fair condition and should be replaced to match the existing trim. Partial remnants of a pre-existing gutter system should be removed. A rain diverter can be installed above the west and south steps to direct water and snow melt away from the porch openings.

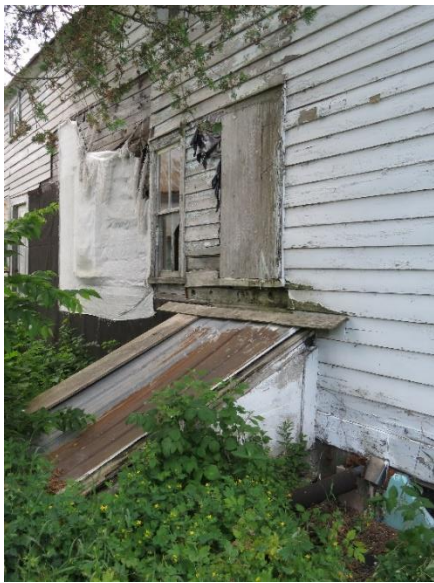
Figure 18 Basement Bulkhead at North Side

A bulkhead on the north side of the Ell leads to the basement. The bulkhead appears to have concrete sides and a mixture of boards and metal roofing material covering the top and is in poor shape. The bulkhead should be removed and a new concrete wall installed with a new metal bulkhead door installed that can be properly flashed with the new clapboard siding.

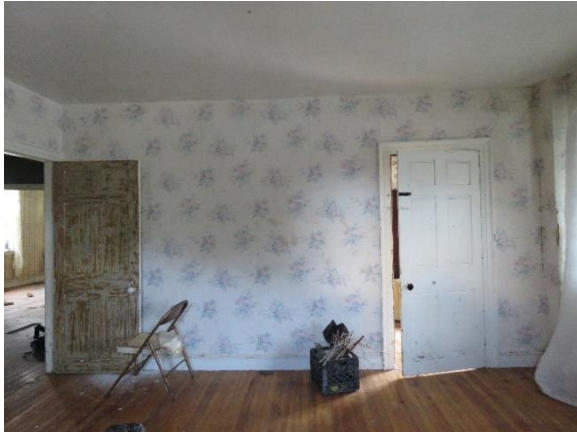
Figure 28 Main Building Northwest Room at First Floor

The interior wood doors in the Main Building are in fair to good condition. The doors on the first floor are six panel doors with the exception of one door leading off the entry to the southwest

room which is a four panel door. The doors on the second floor are four panel doors. The doors should be scraped, prepped and painted or stained. The interior wood doors in the Ell on the second floor vary in style and are in poor to fair condition.

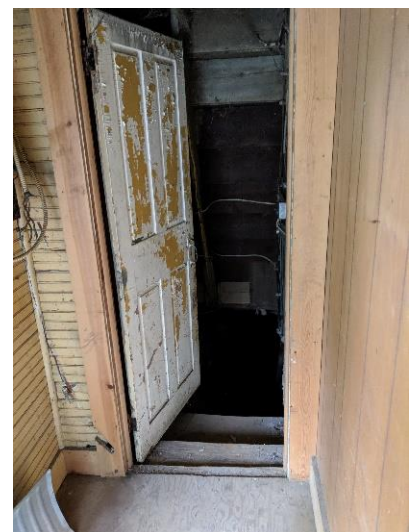
Figure 31 Ell Door to Basement

Two or three doors appear to be salvageable and should be scrapped, prepped and painted. The interior wood doors on the first floor of the Ell are all modern hollow core doors with the exception of the door leading to the basement which is a four panel wood door. The four panel door can be salvaged and scrapped, prepped and painted or thought should be given to replace this with an insulated door since this leads to an unheated basement. The other doors are not historical and can remain or replaced with doors that are more in keeping with the character of the building.

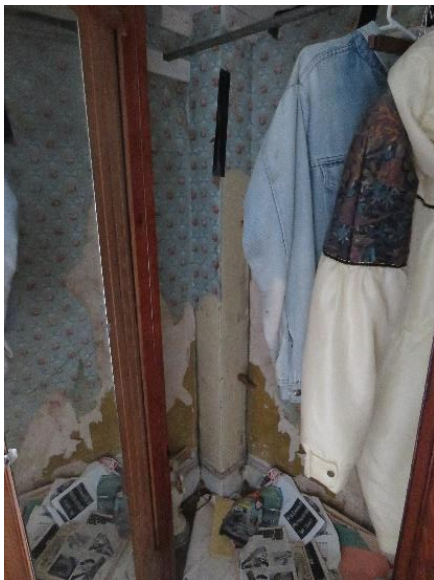
Figure 34 Wall Paper at First Floor NW Room

are built-in drawers, closets and window seat with wood bead board paneling. This should be repaired and refinished. The other walls are wallpapered over most likely plaster on lath. The wall paper is stained and cracked. The wall paper should be removed and the plaster inspected for repairs. Due to the age of the building, it should be anticipated that the plaster behind the wallpaper may be in poor condition and should be removed to studs and gypsum wallboard installed. The ceiling looks like wallpaper has been installed over plaster or wood bead board. This is usually done to cover damaged surfaces. The ceiling looks to be in fair to good condition and may remain. The interior walls inside the closets are plaster with various layers of wallpaper. The wall paper should be removed and the plaster repaired and/or removed and replaced with gypsum wallboard. The hardwood floor appears to be in fair to good condition and should be sanded and refinished.

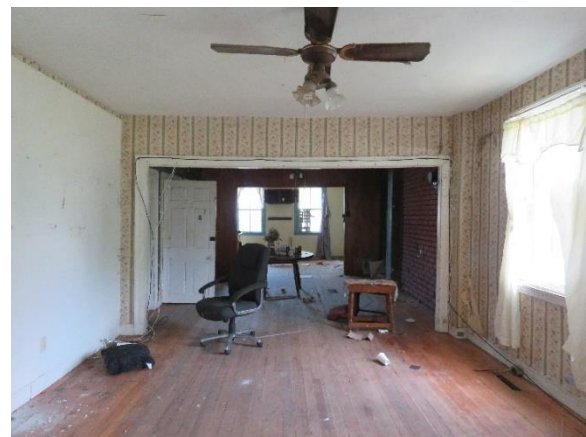
Figure 37 Main Building First Floor SE Room Looking North

The room on the east side of the Main Building is one big room with doors opening into both of the front rooms just described. This room can be divided into three sections. The south section, the center section and the north section. A sunroom opens off the south section. The south and center sections may have been used for a dining area. The north section has a small kitchen area. The south section is directly off the front southwest room and has wallpaper over plaster walls. A layer of gypsum wallboard has been added over the wallpaper on the west wall. The gypsum board and

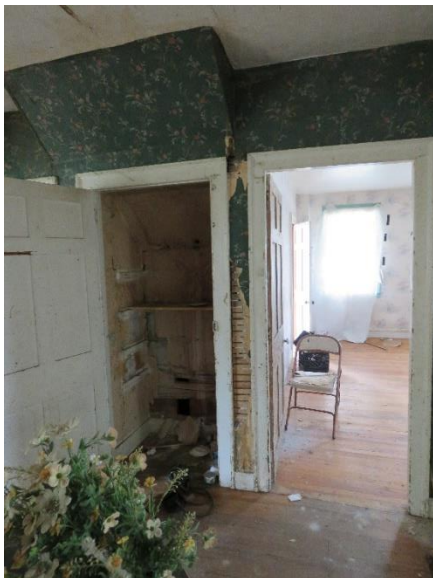
Figure 42 Main Building First Floor Center East Room Looking West

The center section has wallpaper over plaster on the west and south walls. A combination of faux brick and wallpaper over plaster on the east wall and thin wall paneling on the north wall. There is water damage in the southeast corner of the ceiling and wall. A capped stove pipe extends out of the faux brick wall. The ceiling is in poor condition. The wall and ceiling finishes should be removed to the framing and the underlying structure inspected for damage and repairs. A new gypsum wallboard ceiling and walls should be installed. The wood flooring in this area is in fair to good condition with an area in the center with missing boards. New boards should be installed to match the existing and the floor should be sanded and refinished.

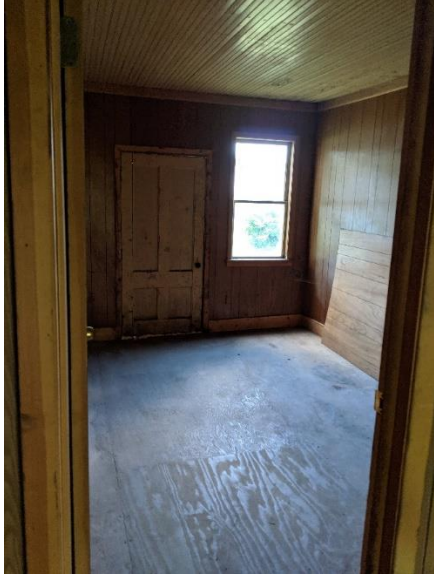
*Figure 53 Ell First Floor Apartment
NE Corner Room*

There are four rooms off of the main room. The room opposite the entrance has a wood bead board ceiling that looks in fair to good condition and can be scrapped, prepped and painted. This is the only room without a wood flooring. Instead there is a plywood floor. A new flooring material will need to be installed over the plywood.
